SOME ASPECTS  
OF  
POSTERIOR RESIN RESTORATIONS:  
AN  
IN VIVO  
AND  
IN VITRO STUDY.

Research report submitted in partial fulfilment for the degree of  
MASTER of DENTAL SURGERY.

Department of Dentistry,  
The University of Adelaide.

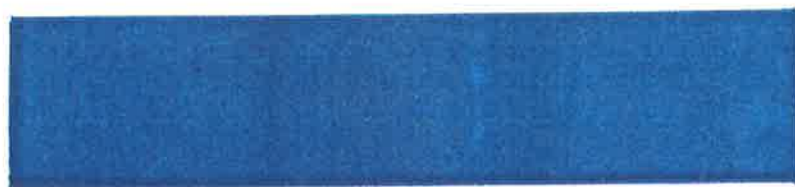
Blue represents the flat glass slabs.

Mylar strips are placed between the glass slides and the resin/washer assembly. The top glass slab was removed prior to curing. The mylar strips were removed following curing to enable a 3 mm hole to be drilled through the centre of the resin disk. This then allowed the placement of an uncured increment for comparison.

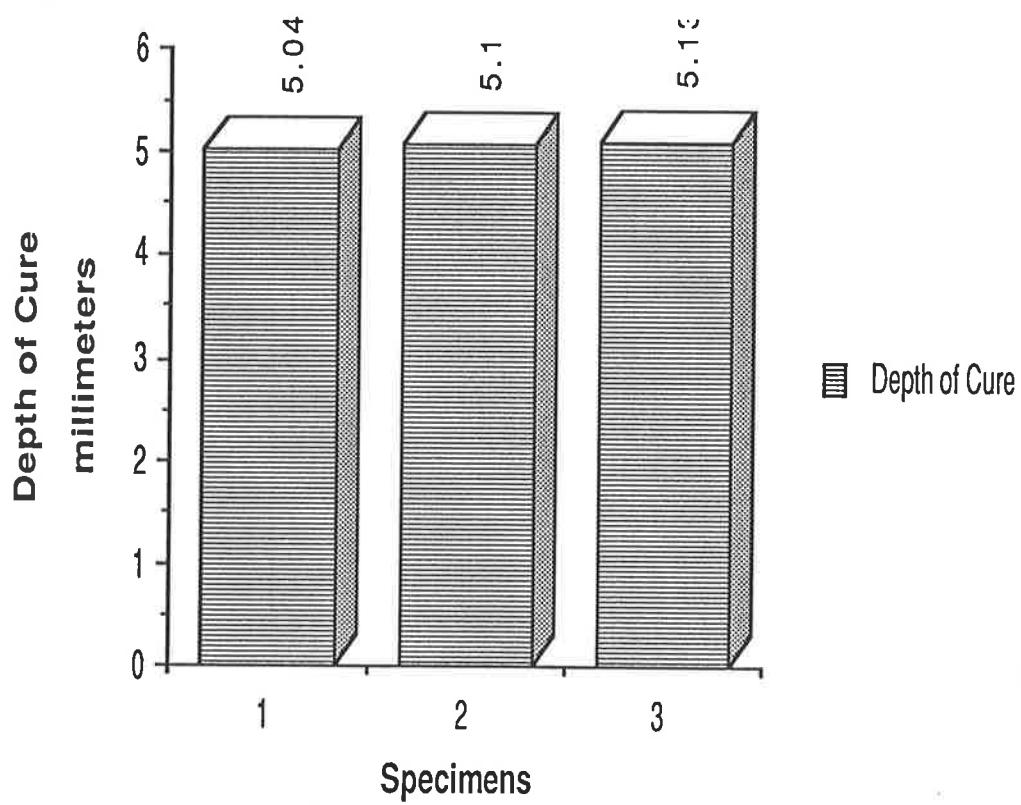
Graph 6.2.1.a

The results for the control group, cured and measured according to AS 1278-1982 appear in graph 6.2.1.a. The most significant result is an indication that the cured resin begins to show significant failure in the matrix well before the AS 1278-1982 standard is reached. In all cases the scratch was observed to increase in width at a point well short of the AS 1278 -1982 measurement, indicating a decrease in the strength of the resin well before the accepted depth of cure. The Scanning Electron Micrographs of the scratch depict a tearing of the matrix, after only 60% of the ASA standard value has been traversed, to leave fissures extending down through the sample, ( figures 6.2.1.2.a, b & c). These fissures clearly appear to be through the resin matrix, with distinct intact filler particles being left untouched. This would indicate resin failure within the matrix due to a reduction in the conversion rate of carbon double bonds to form crosslinks between monomer molecules. Thus the depth of cure would appear to be compromised.

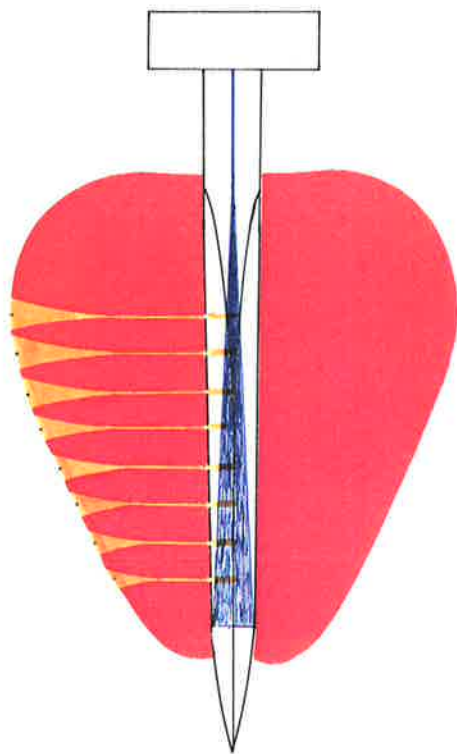
**Figure 6.3.2.4.b**

Diagram of the flat specimen of resin cured but light transmitted through the wedge only. The depth of cure was measured using the same method as in AS 1278-1982, where the uncured resin was simply scraped off and the distance calculated using a micrometer. In this case the midline of the wedge was used as the reference or zero point. In addition the specimen was scratch tested and the yellow lines with flared ends represent the result found. This correlates linearly with the scratch tests conducted in the split steel moulds.

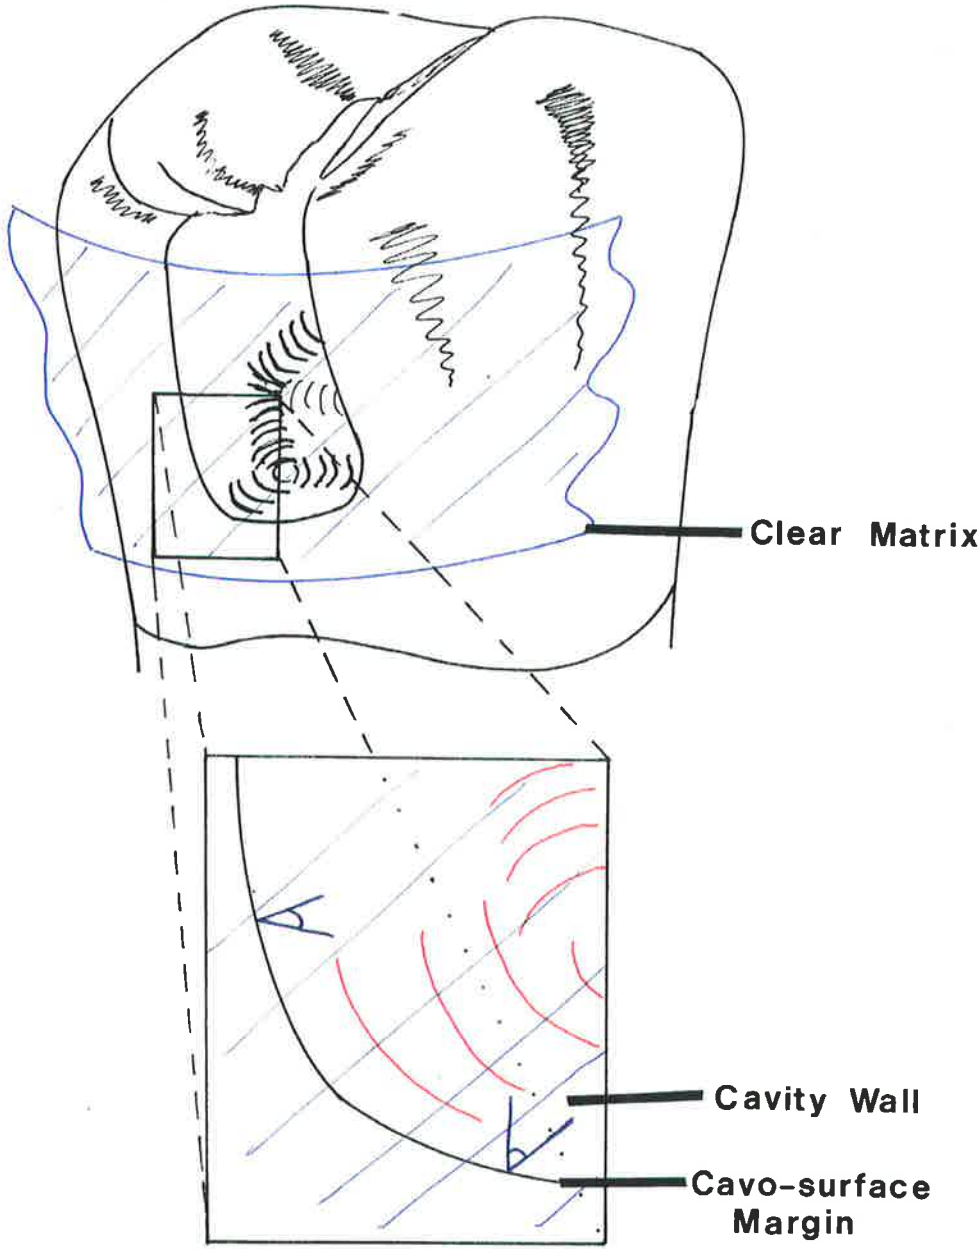
Diagram of the temporary line angle formed between the cavo-surface margin and the matrix band. The clear matrix is outlined in blue with a few blue streaks, the rounded internal line angle are shown in red, the tooth is outlined in black and the two angle representations are to high-light the temporary line angle.

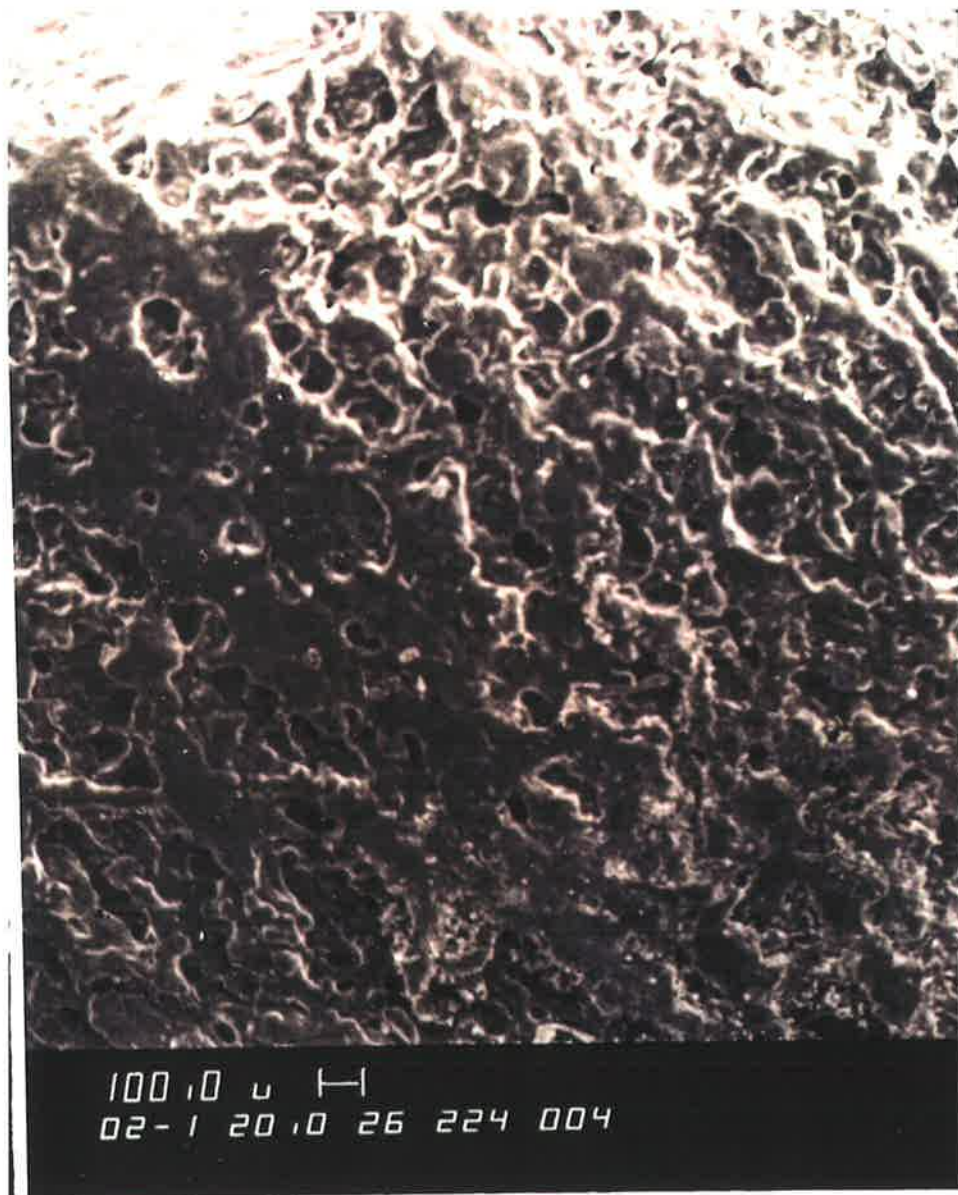
Figure 7.3.5.2.b

S.E.M. micrograph of a very sticky resin surface following removal of an instrument. (Magnification : X 20).

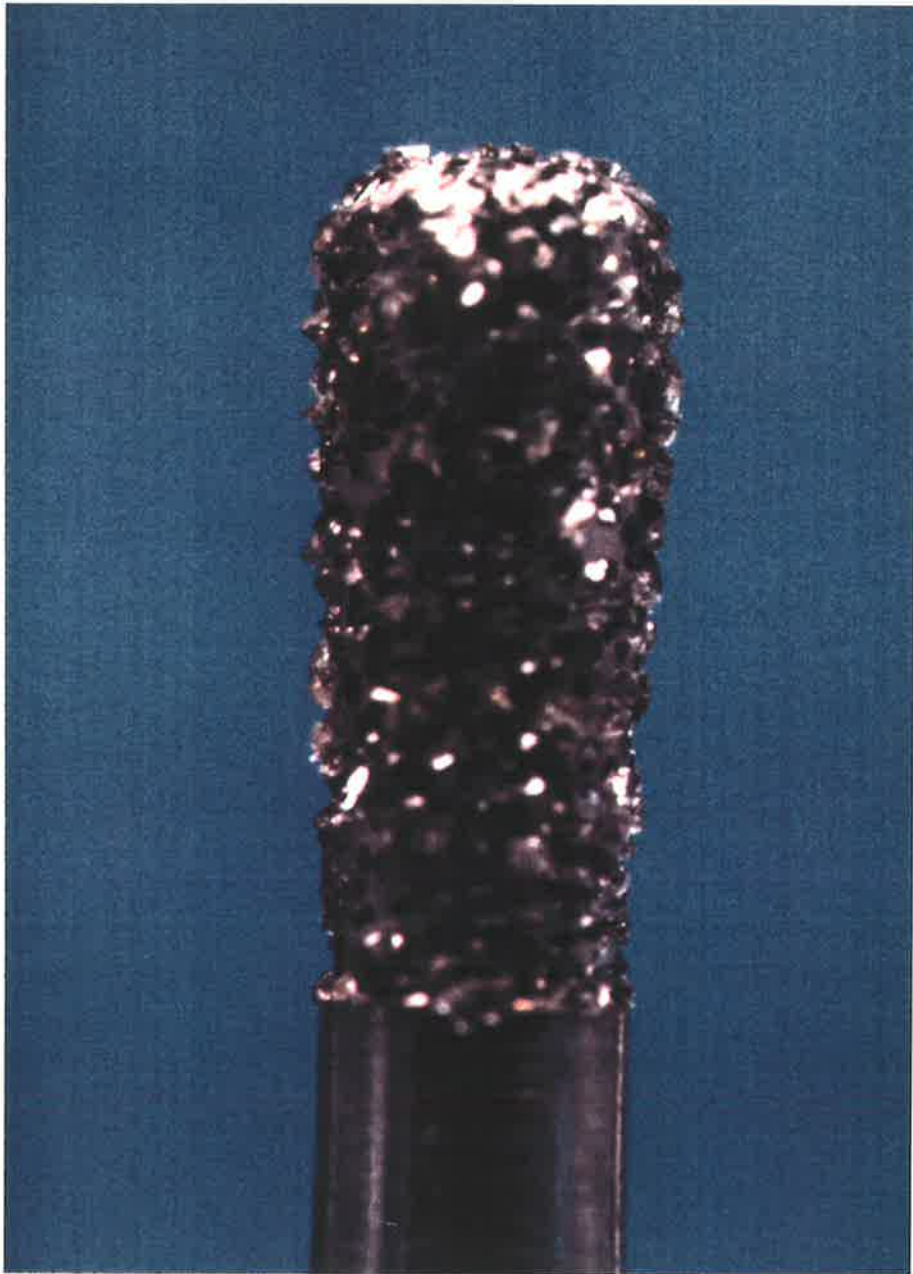
Pear-shaped diamond bur used for the main cavity outline form. The diameter is 1.2mm

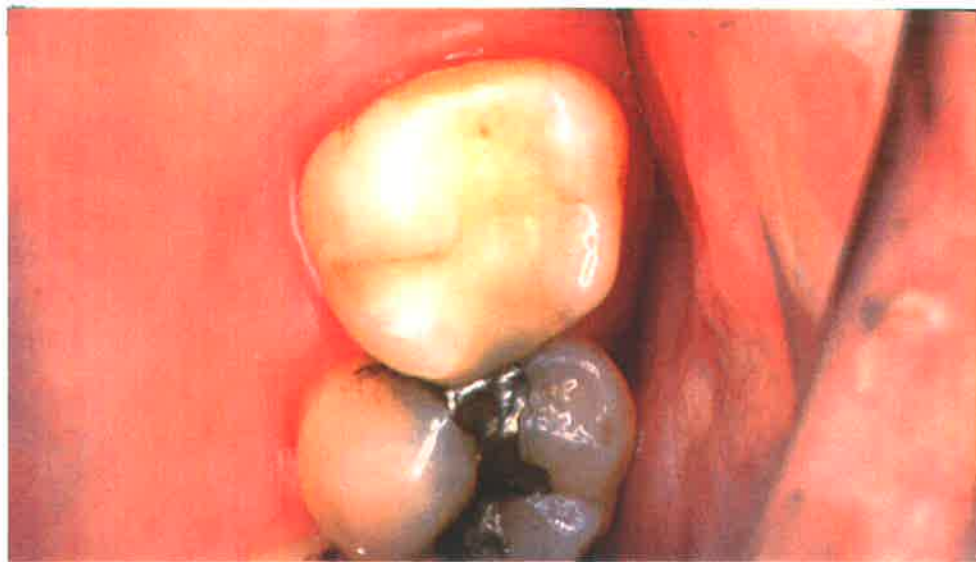
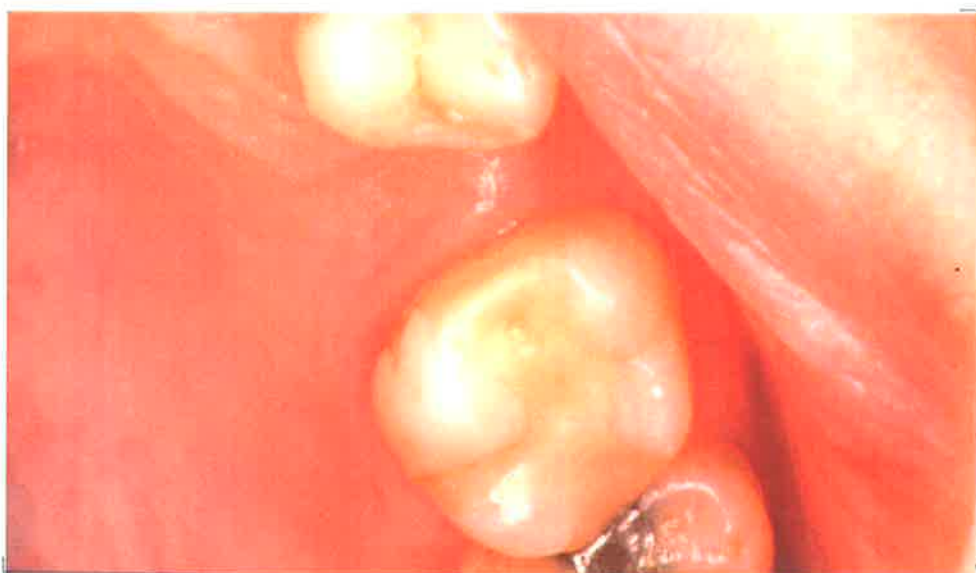
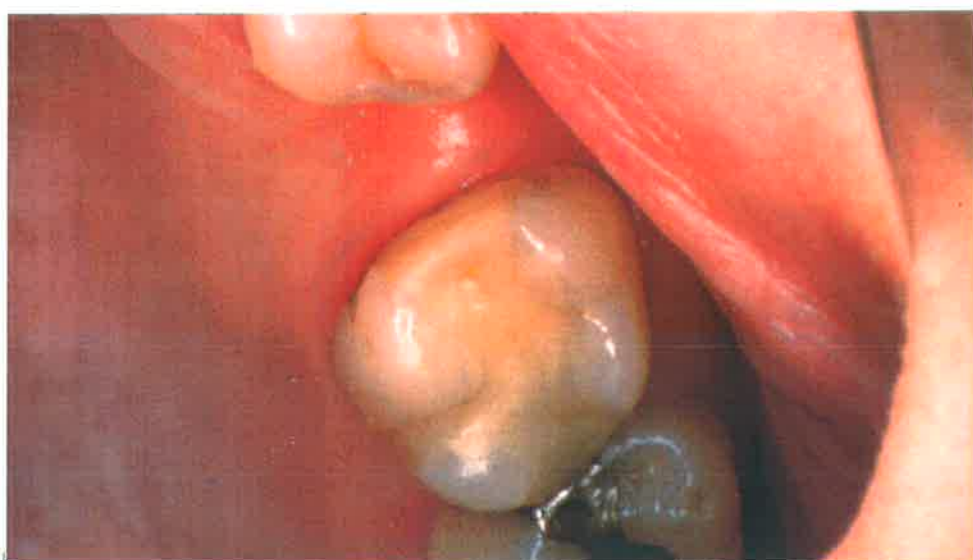
The eighteen-month recall for the same restoration as above, with even further deterioration. There is however, no bulk failure or any other clinical signs or symptoms to indicate failure of this restoration.

- 9.2.5.a. Photograph of a recording impression from which a replica was made in Araldite D. 279
- 9.5.1.a, top view. This restoration is seen at the six month recall. It is a P-30 MOD restoration. The surface and margins have started to stain. 282

- 9.5.1.b, middle view. The same restoration as above, at the twelve month recall. The surface and margins are stained even further. 282

9.5.1.c, bottom view. The eighteen month recall for the same restoration as above, with even further deterioration. There is however no bulk failure or any other clinical signs or symptoms to indicate failure of this restoration. **282**

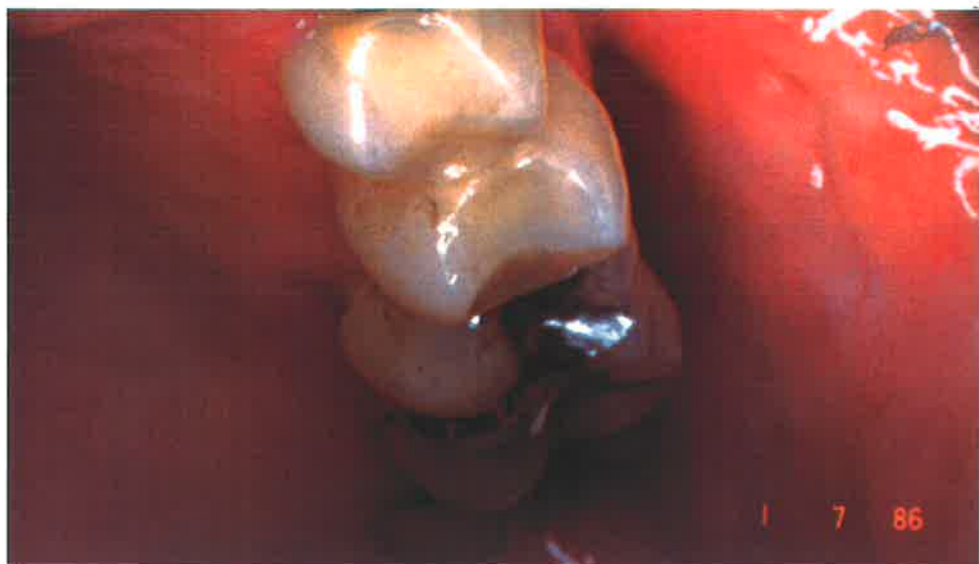
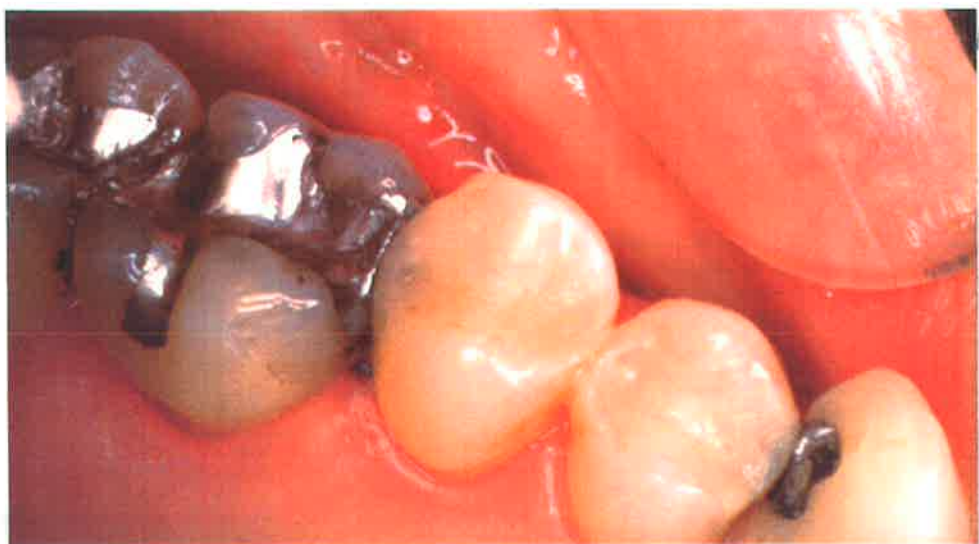
This photograph was taken at the eighteen-month recall. As with the previous photograph, the Dispersalloy of the 26 has deteriorated, but the surfaces of the 24 and 25 are still good. The 25 does however have some small occlusal wear marks, (figure 9.5.1.o).

9.5.1.d, top view This series of restorations is taken at the polishing appointment after insertion. The 27 ( obscured ) has had a MO Ketac-Silver restoration, the 26 has a MODL Dispersalloy restoration, the 25 and 24 have MOD Herculite restorations. The six month recall did not show any significant deterioration. **284**

9.5.1.f This photograph was taken at the eighteen month recall. As with the previous photograph, the Dispersalloy of the 26 has deteriorated, but the surfaces of the 24 and 25 are still good. The 25 does however have some small occlusal wear marks, (figure 9.5.1.o). **284**

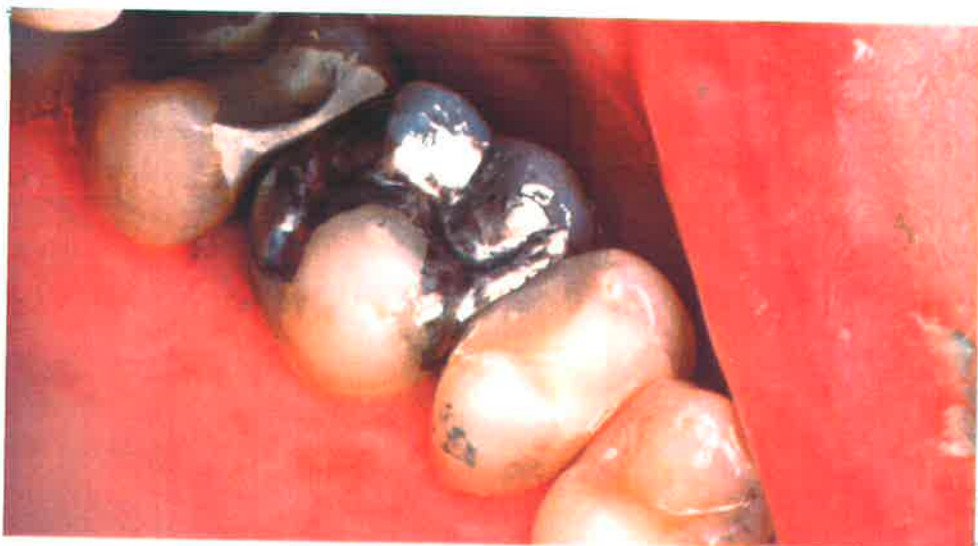
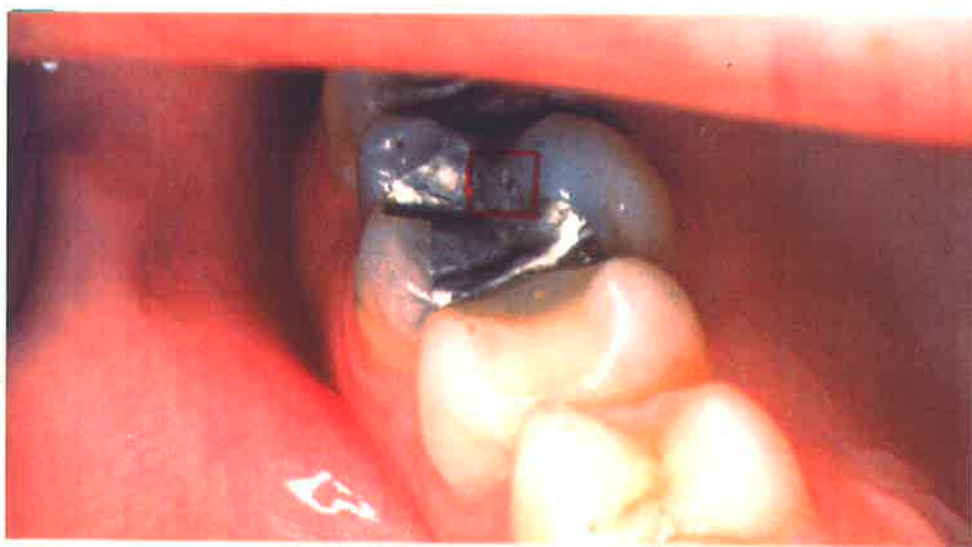
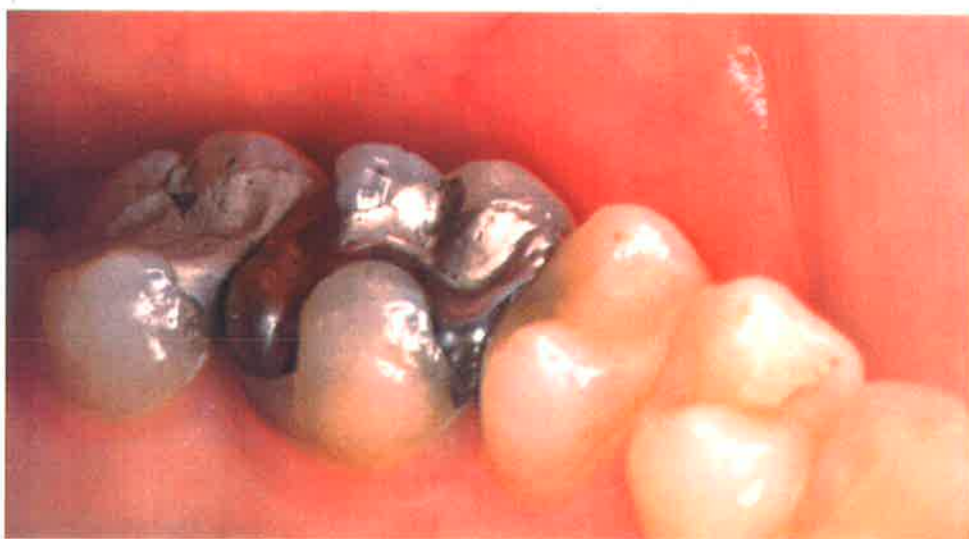
This photograph is taken of the same series as above, but at the eighteen-month recall. The significant features are the considerable loss of form and fracture of the Ketac-Silver and loss of amalgam on the distal marginal ridge of the 26, (figure 9.5.1.k). The mesial marginal ridge of the 25 also had a bulk fracture, which was a thin section of restorative material overextended past the cavo-surface margin. This is seen more clearly in figures 9.5.1.l and m.
