**Failure mechanisms of geocell walls and junctions**

Geotextiles and Geomembranes, 2019; 47(2):104-120

# 1                    **Failure Mechanisms of Geocell Walls and Junctions**

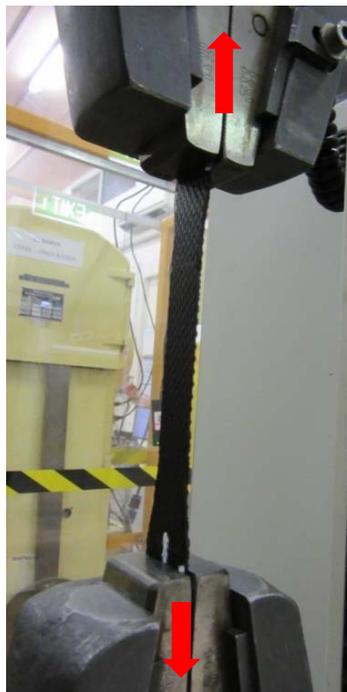
795 **Figure 5. Uniaxial tensile strength test on geocell wall: (a) specimen**  
 796 **configurations, (b) testing overview.**  
 797

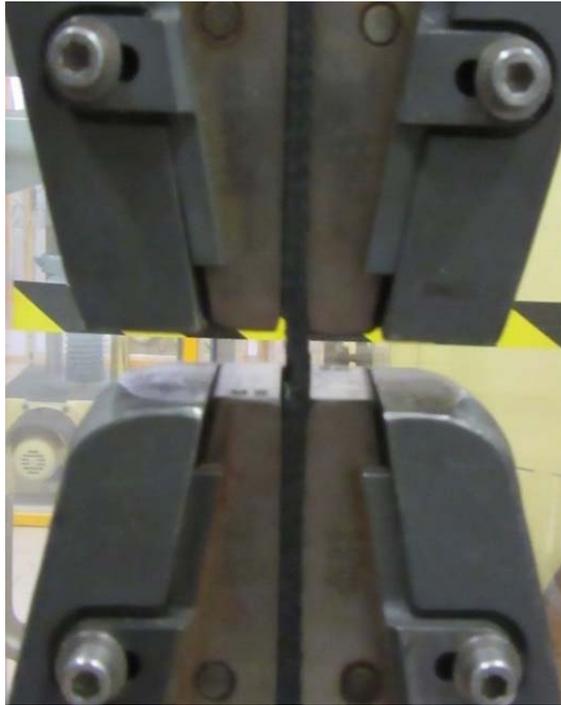
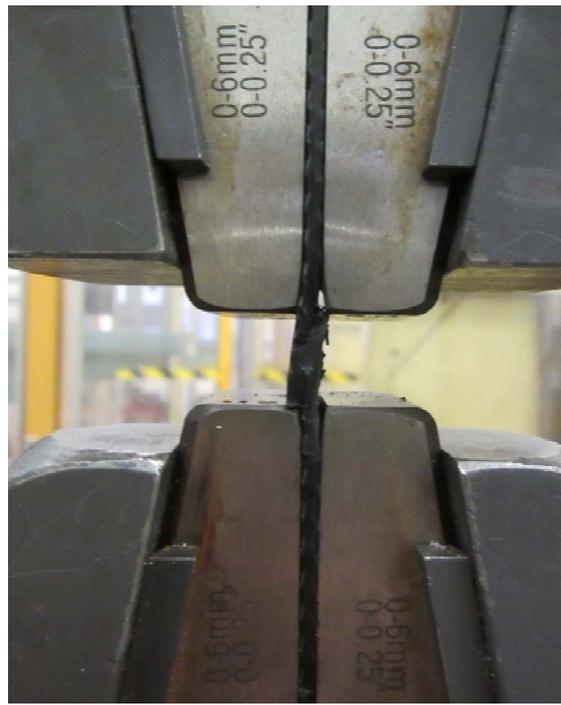
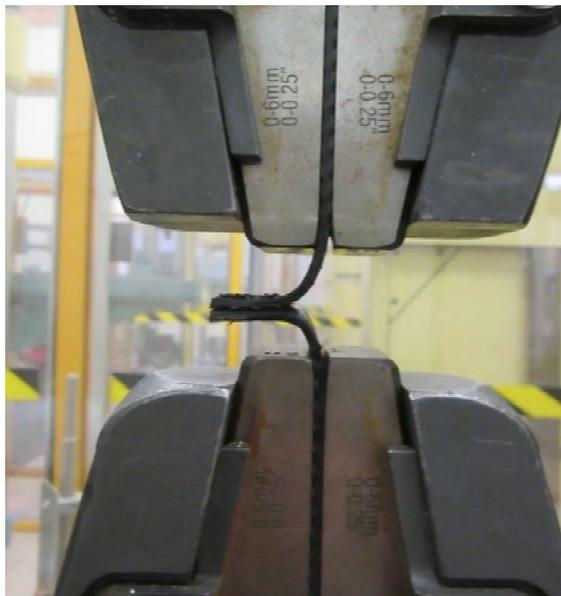
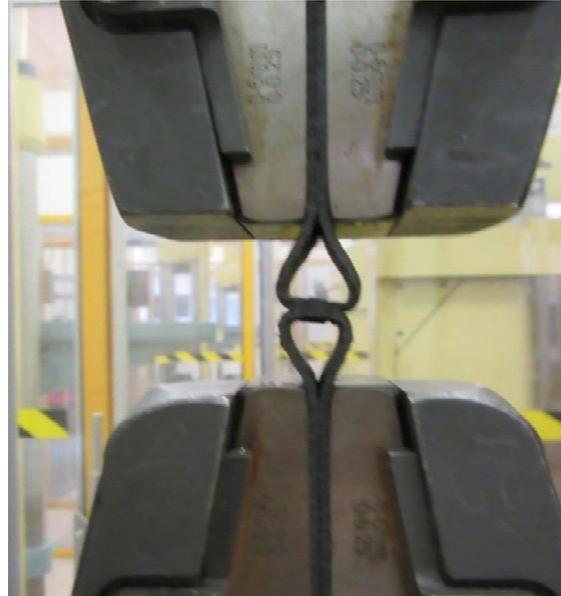
813 **Figure 9. Clamped specimens: (a) tensile strength, (b) shear junction**  
814 **strength, (c) seam strength, and (d) split strength.**

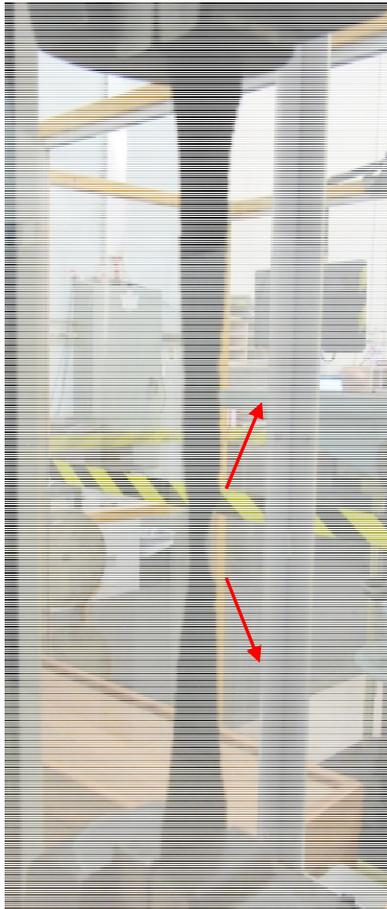
820 **Figure 11. Failure modes of cell-wall specimens subjected to uniaxial**  
 821 **tension: (a) and (c) sudden failure, (b) and (d) ductile failure mode of**  
 822 **HDPE.**  
 823

290 Photographs taken during the tests were able to capture the different elongation  
291 modes, as shown in Figure 11. Although the loading rates of the specimens  
292 were identical (50 mm/min), specimens 1, 2 and 4 fractured at elongations  
293 approximately half of those exhibited by specimens 3 and 5. It can also be seen  
294 that the two subsets of specimens experienced different failure mechanisms.  
295 The failure of the specimen 3 in Figure 11(a) initiated from the right-hand-side  
296 edge, then propagated towards the center (as indicated by the red arrows) and  
297 the rupture point was at the left-hand-side edge. Whereas, specimen 5, in  
298 Figure 11(b), elongated vertically and exhibited significant elongation. In  
299 addition, the photographs of the failed specimens are shown in Figure 11(c) and  
300 (d). The post-failure forms of the 5 specimens exhibit good agreement with the

301 corresponding stress-elongation relationship. For specimens 1, 2 and 4, the  
302 rupture surfaces (highlighted by red-dashed lines) are much sharper with little  
303 elongation, whereas specimens 3 and 5 failed more gradually.

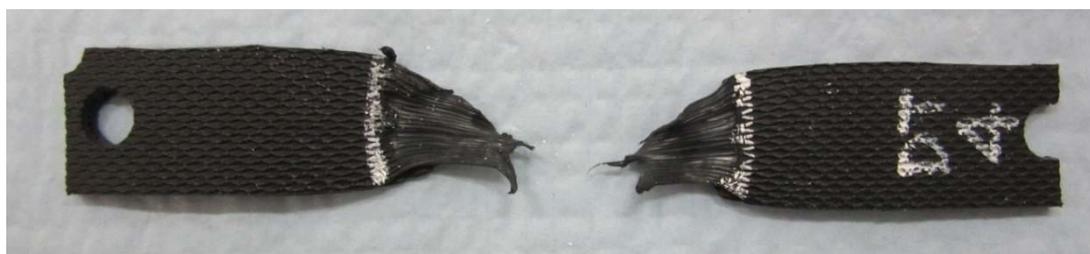
854 **Figure 18. Failure modes of the geocell junction subjected to uniaxial**  
855 **tension: (a) initial stage (pre-peak), (b) failure mode 1 (post-peak), (c)**  
856 **failure mode 2 (post-peak), and (d) ruptured specimen 1.**  
857

433 Two failure modes were identified for geocell junctions under tensile loading,  
434 which can be observed in Figure 18(b) and (c). All specimens experienced  
435 identical behavior in their initial stage of failure, with the elongation initiating  
436 from approximately the middle of the welds, as shown in Figure 18(a). The initial  
437 stage was then followed by two different failure modes. Specimens 2-4  
438 continued elongating in a vertical manner until rupture occurred. Whereas, for  
439 specimen 1, the fracture was initiated from the left-hand-side after reaching its  
440 peak tensile strength and followed by rupture which propagated towards the  
441 right-hand edge. Similar failure modes were observed on the cell-wall which  
442 was attributed to the stress concentration caused by inconsistent indentation  
443 depths (cf §3.1 Cell-Wall: Uniaxial tensile strength). These observations agree

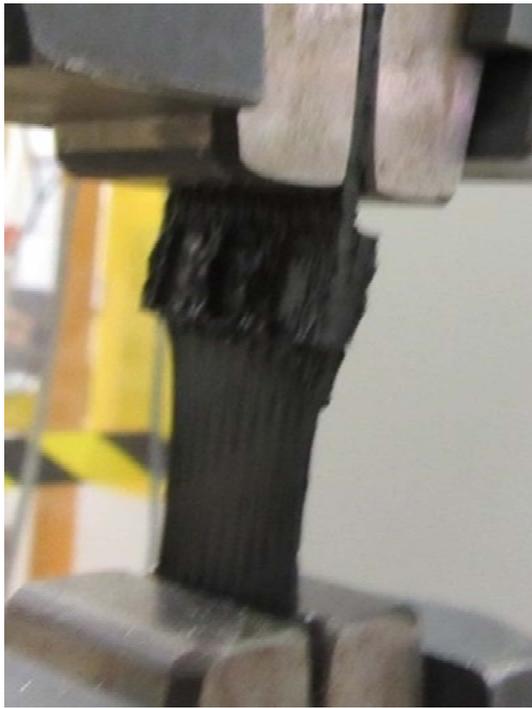
862 **Figure 20. Failure modes of geocell junctions subjected to shear force:**  
863 **(a) oblique view and (b) side view during testing, and (c) failed specimen.**  
864

459 All specimens experienced similar failure modes, where the rupture occurred  
460 adjacent to the junction, as shown in Figure 20. This indicates that the junction  
461 is unlikely to fail during shearing and the shear strength of the junction is  
462 significantly higher than the peak shear stresses obtained from the present  
463 experimental program, yet it is more vulnerable to tensile stress. This  
464 observation is confirmed by the elongation mode in Figure 20(b), where the  
465 specimen deformed only in the cell-wall strip, while the junction remained intact.  
466 Therefore, it is worthwhile to investigate the tensile strength of the cell-wall  
467 strips induced by the shearing action, and the tensile stress versus elongation  
468 relationships are plotted in red in Figure 19. Interestingly, under the action of  
469 shear, the tensile strength of the cell-wall was considerably higher than the
