# PEELING OF PLATES ADHESIVELY BONDED TO REINFORCED CONCRETE BEAMS

A thesis presented for the degree of

**Doctor of Philosophy (Ph.D)**

**DEPARTMENT OF CIVIL AND ENVIRONMENTAL ENGINEERING,  
THE UNIVERSITY OF ADELAIDE, ADELAIDE.**

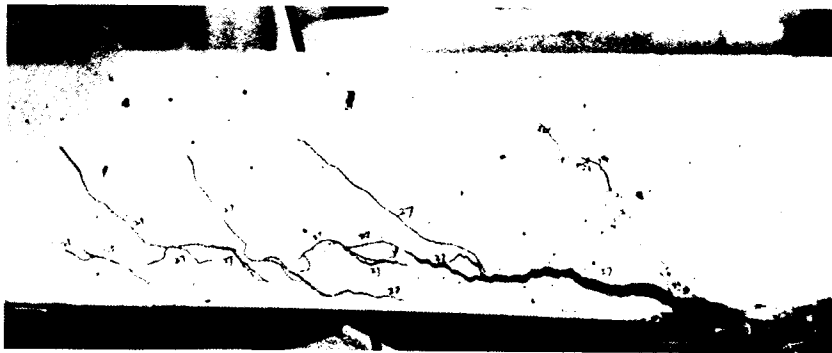
**Fig.2.3. Plate-end in predominantly shear region**

When the plate ends are placed in predominantly shear region (refer Figs.2.5a and 2.5b), failure due to plate separation occurs as shown in Fig.2.3. This mode of debonding caused by the shear cracks is referred to as shear/bond failure (Jones, Swamy and Charif 1988 and Swamy, Jones and Bloxham 1987) or shear peeling (Oehlers 1989). Failure does not occur at the plate/adhesive or adhesive/concrete interfaces but fracture invariably takes place in the concrete cover (Swamy, Jones and Bloxham 1987 and Oehlers 1992). This debonding mechanism is initiated by a shear crack that induces a horizontal crack at the level of the tension reinforcement which propagates rapidly towards the load point and eventually causes separation of the plate (Swamy, Jones and Bloxham 1987 and Oehlers 1992), as shown in Fig.2.6.

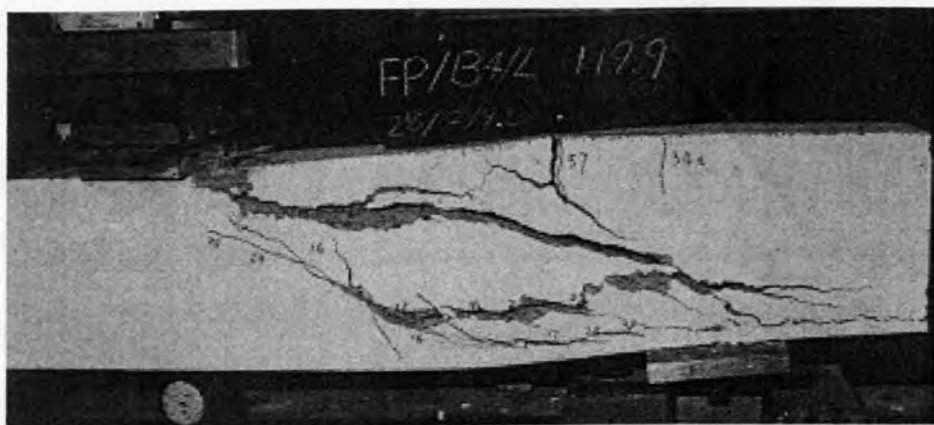
The tests revealed that all the plated beams failed by the formation of extensive diagonal shear cracks. The debonding is due to the horizontal debonding crack that originated from the diagonal crack closest to the support; the debonding crack then extended backwards to the support and then to the end of the beam as shown in Fig.2.9. The test results revealed that the shear load to cause complete peeling of the plates beam were about 88%, 160% and 215% more than the shear strength  $V_{uc}$  of the unplated beam for the beams bonded with 3 mm, 5 mm and 10mm plates respectively.

**Fig.2.9. Failure mode of plated beams**

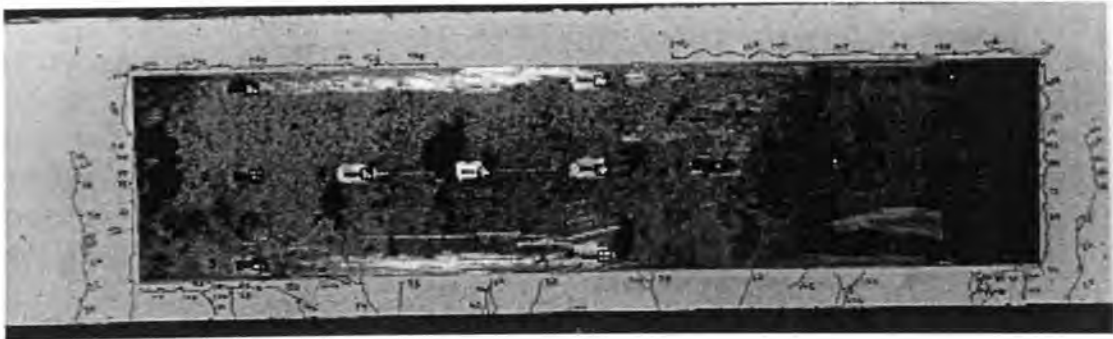
The only study on this aspect was conducted by Oehlers, Nguyen and Bradford (2000b). Six 5 m long beams were tested with plates in constant moment regions as shown in Fig.2.12. The plate thickness was varied from 6 to 12 mm and the plate depth from 60 to 240 mm. All the beams failed by flexural peeling in a similar fashion to the tension face plated beams. Failure mechanisms were the same both for the shallow and deep plated beams. The debonding was initiated by the formation a flexural crack at the plate end at a very low load, it stabilised until there was very rapid crack propagation at the maximum peeling moment. This rate of debonding is extremely important in plated beam construction because it means that initial peeling is not a prelude to unstable crack propagation or ultimate peeling. This is in contrast

**Fig.2.12. A typical flexural peeling of a side plated beam (Nguyen and Oehlers)**

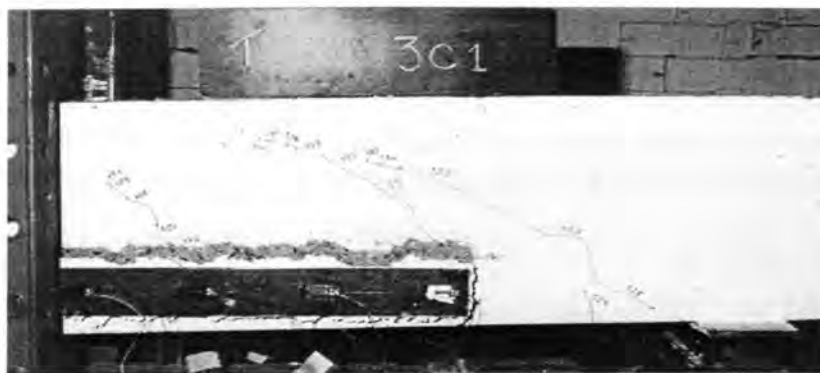
$f_b = 4.49$  MPa and  $E_c = 40.4$  GPa. A typical peeling pattern observed due to shear/flexure interaction is shown in Fig.2.13.

**Fig.2.13. A typical shear/flexural peeling interaction in side plated beam**

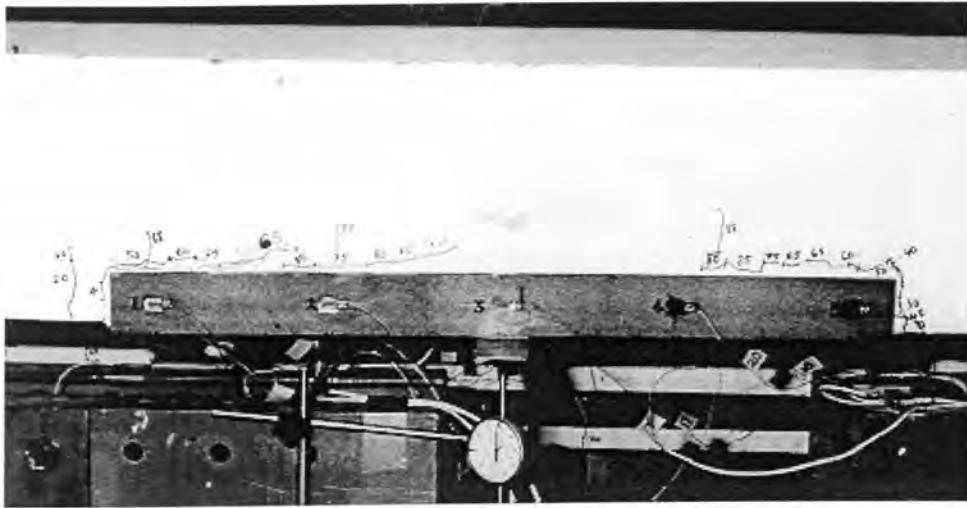
In yet another unique study, Nguyen and Oehlers (1997b) evaluated the performance of bonded angles in which the plate ends were subjected to bending moments only and a failure mechanism similar to side plate was observed, as shown in Fig.2.18.

Fig.2.18. A typical flexural peeling of angle plated beam (Nguyen and Oehlers)

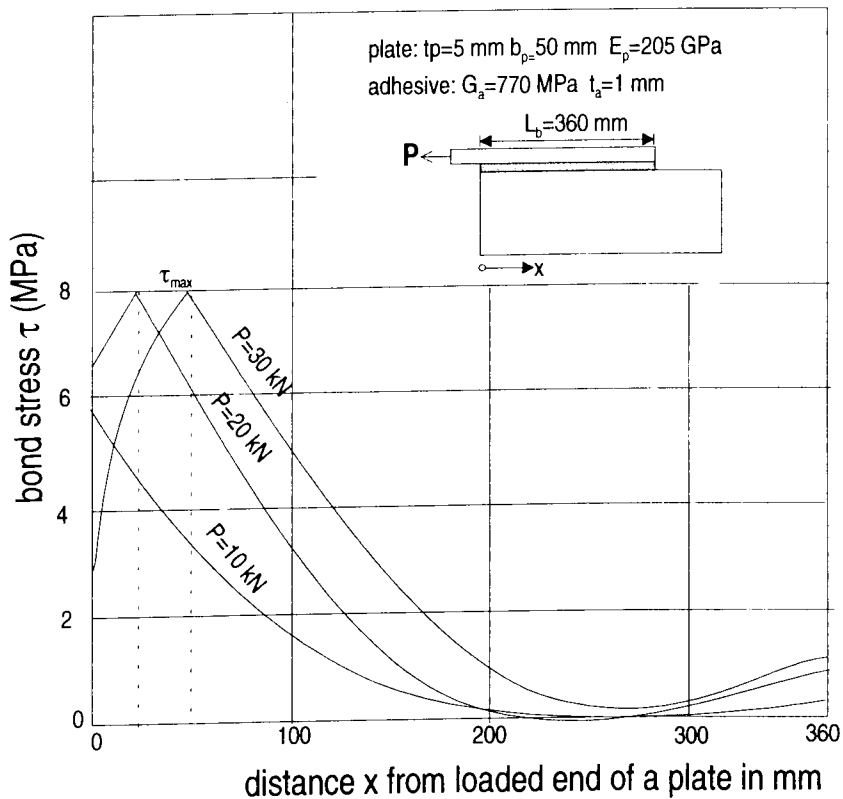
**Fig.4.2. Typical test results by Ranisch and Rostasy**

there is no further increase in the axial load carrying capacity of the plate/concrete interface. A typical test results for a 50 mm wide and 5 mm thick steel plate is shown in Fig.4.2. In this test, the bond length  $L_b$  for the plate is 360 mm and the adhesive layer is 1mm thick and it has a shear modulus  $G_a$  of 770MPa. The bond stress distribution along the anchorage length has a peak in the proximity of the loaded end of the plate and the position changes with the applied load due to the onset of concrete cracking. However, the peak bond stresses does not increase beyond a certain applied load which in this case is 20 kN. Even if the bond strength is locally exceeded, the concrete will still be able to carry load by a combination of shear and friction, i.e. aggregate interlocking across the debonding crack.

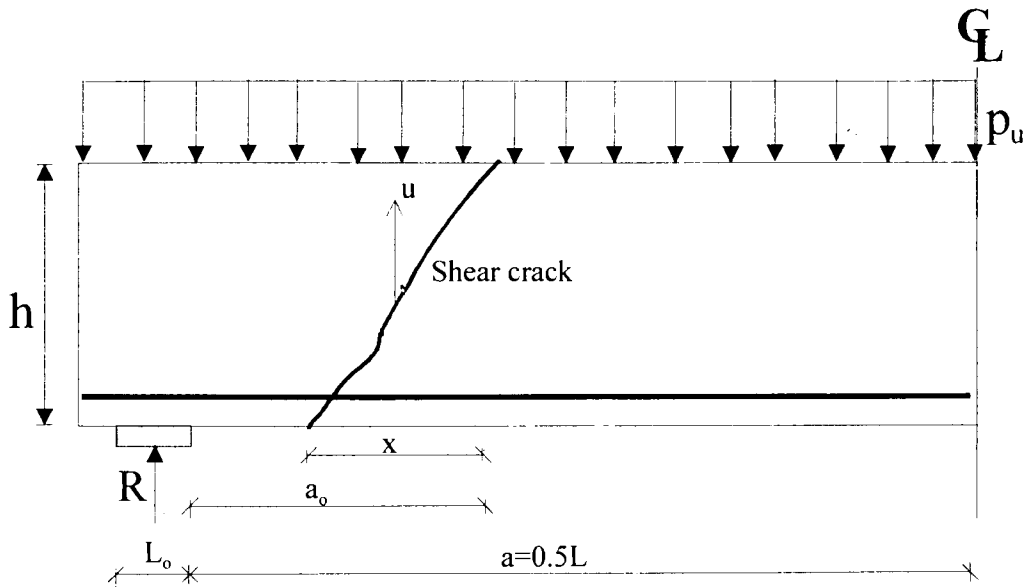
**Fig.5.9. Beam subjected to uniformly distributed load (Zhang 1994)**

Consider the RC beam shown in Fig.5.9 that is subjected to a uniformly distributed load of intensity  $p$  per unit area over the entire span.

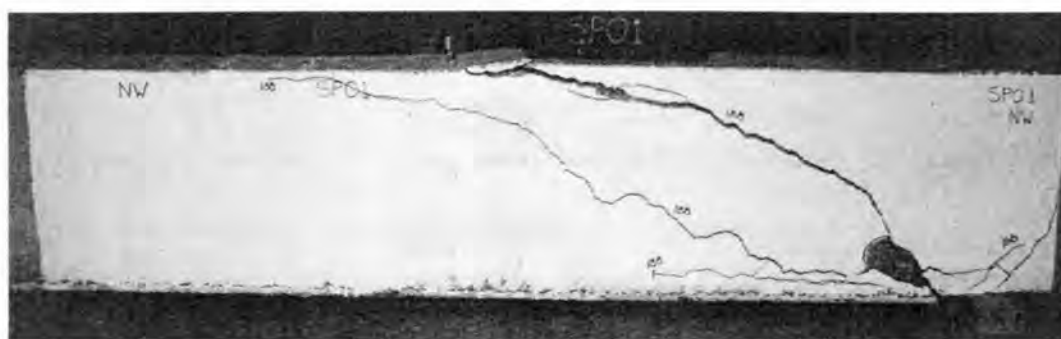
Till  $V=137$  kN ( $P=182$  kN), no cracks were observed. After a small increase in the applied load of 3 kN, corresponding to a shear load  $V=140$  kN ( $P=185$  kN), a critical diagonal shear crack occurred near the plate end. The diagonal crack extended to the beam top near the inner edge of load patten and caused the external plate to peel along the concrete cover as shown in Fig.6.8. Shear failure of the concrete beam occurred simultaneously with shear peeling of the plate; shear failure occurred due to the formation of another diagonal crack from the same root which split the shear span into two as can be seen in Fig.6.8. By comparing the crack patterns in Beam SPREF in Fig.6.6 and Beam SP01 in Fig.6.8, it can be seen that the diagonal crack was forced to initiate adjacent to the support in case of SP01. This has caused the shear strength of the span SP01 to increase from 81 kN to 140 kN, i.e. 63% increase in shear strength.

**Fig.6.8. Failure of SP01**

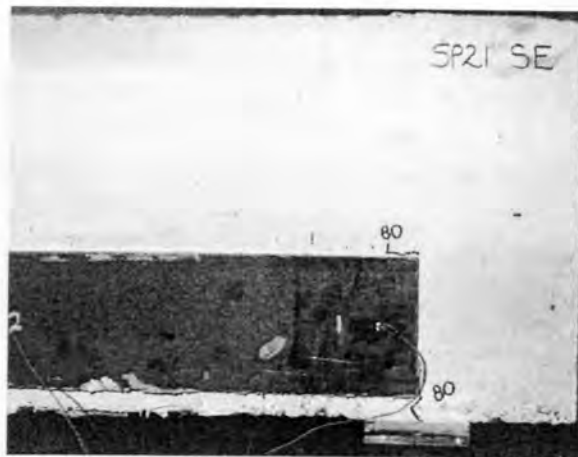
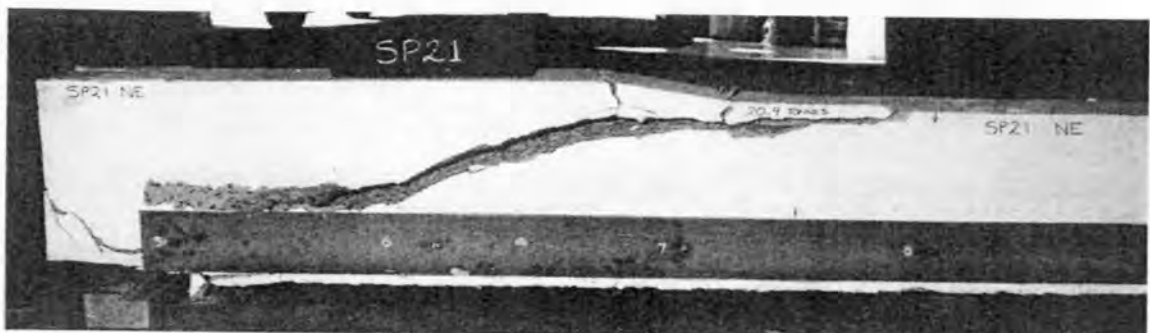
At a shear load of 60 kN ( $P=80$  kN), a vertical crack over the support and along the plate edge appeared as shown in Fig.6.11a; no other crack was visible till the shear load was increased to 155.6 kN ( $P=209$  kN) at which a sudden diagonal shear crack formed that cut across the side plate and extended along the top edge of side plates to the load point, as shown in Fig.6.11b. The shear failure of the beam and shear peeling of both side plates occurred simultaneously. The plates were pushed down to the support and the beam top was fractured into pieces.

(a) Crack at plate end at  $P= 80$  kN

(b) Failure of SP21

Fig.6.11. SP21:Crack pattern

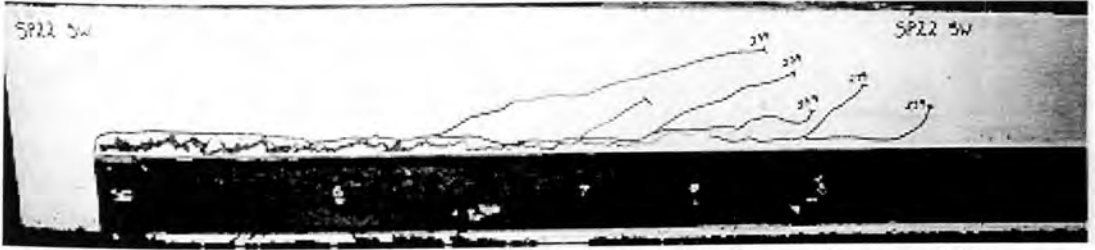
Cracks were not observed until the applied shear load  $V$  was 161.9 kN ( $P=239$  kN), when a long debonding crack formed along the top edge of both side plates. This immediately led to the simultaneous shear peeling of both side plates by the formation of a number of diagonal cracks at regular intervals originating from the horizontal peeling crack as shown in Fig.6.14. Unlike SP21 where the load immediately reduced to zero after failure, in this case the shear load dropped from 161.5 kN to about 100 kN as can be seen from Figs.6.15a and 6.15b which depict the variation of longitudinal strains in the side plates. The maximum strain recorded at the instance of shear peeling was 895 microstrains in the north side plate and 857 microstrains in the south side plate. The shear load-deflection variation is shown in Fig.6.16.

Fig.6.14 SP-22 : Formation of debonding crack and shear peeling

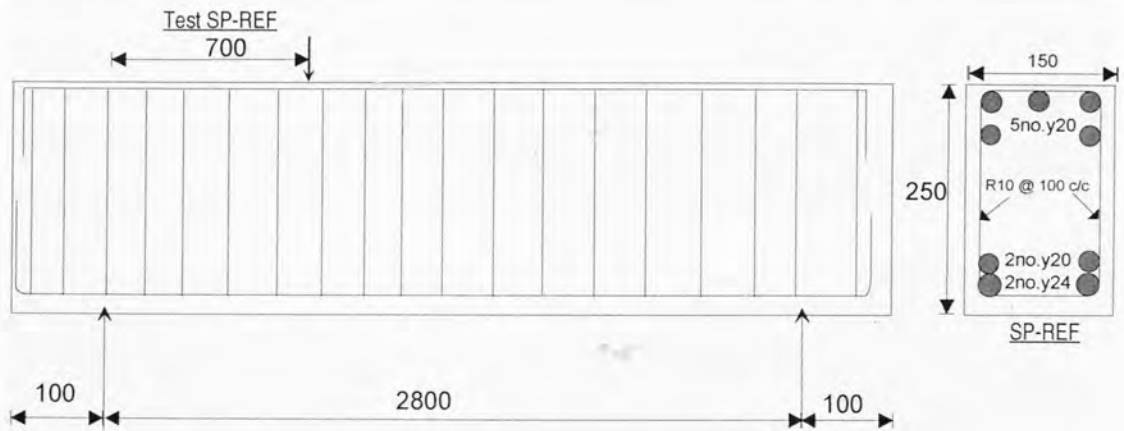
Out of the three beams that were used for this study, one beam was tested without bonding any plates to quantify experimentally the shear strength of the RC beam and this test was denoted as SP-REF as shown in Fig.7.2. The other beams were bonded

**Fig.7.2. Test SP-REF**

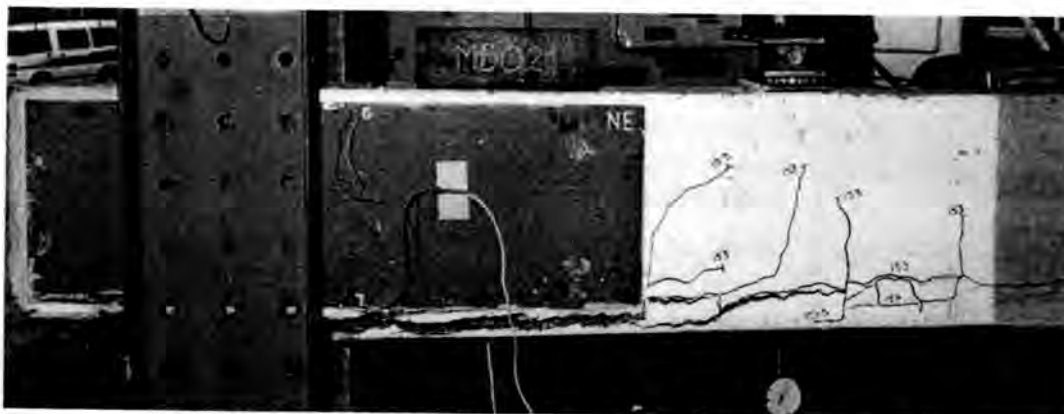
As the side plates were covering the most of the beam depth and also the length of the shear span, the formation of the cracks could not be observed till the debonding of the tension face plate occurred at an applied load of 153 kN (Shear load  $V=114.1$  kN). The corresponding bending moment at the tension face plate end was 51.3 kNm. The peeling of the tension face plate occurred by the separation of the plate from the concrete by long debonding cracks that were preceded by a series of shear cracks as shown in Fig.10.7. This caused the beam to shed the load instantly to 95.3 kN ( $V=71.1$  kN) and hence, the test was terminated.

**Fig.10.7. Test MB-02: Peeling of the tension face plate**

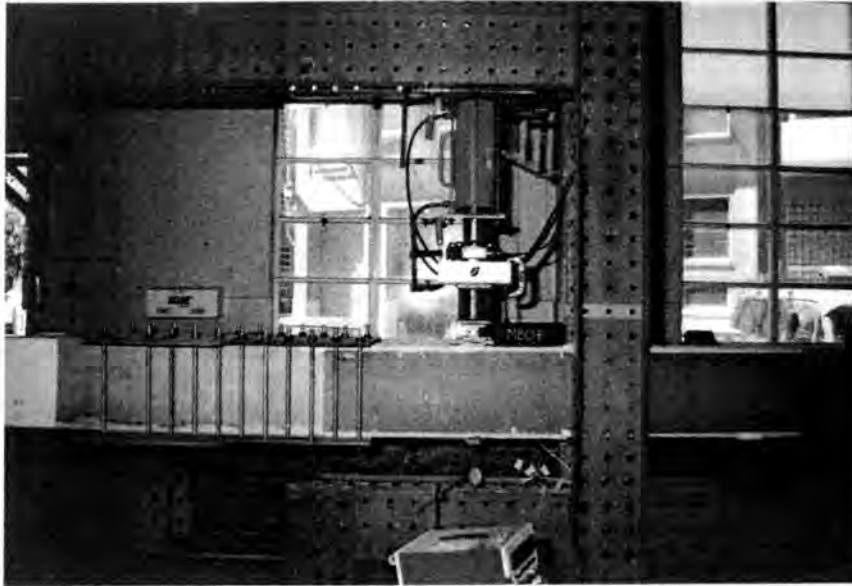
Test-MB -04 was conducted on the beam bonded with the tension face plate and also bonded with 1830 mm long side plates, as shown in Fig.10.2c. To avoid any premature flexural failure, additional reinforcement in the form of bolted plates were

provided in the long shear span as shown in Fig.10.16. The shear force ( $V$ ) in the span tested was 74% of the applied load ( $P$ ).

**Fig.10.16. MB-04-Test set-up**

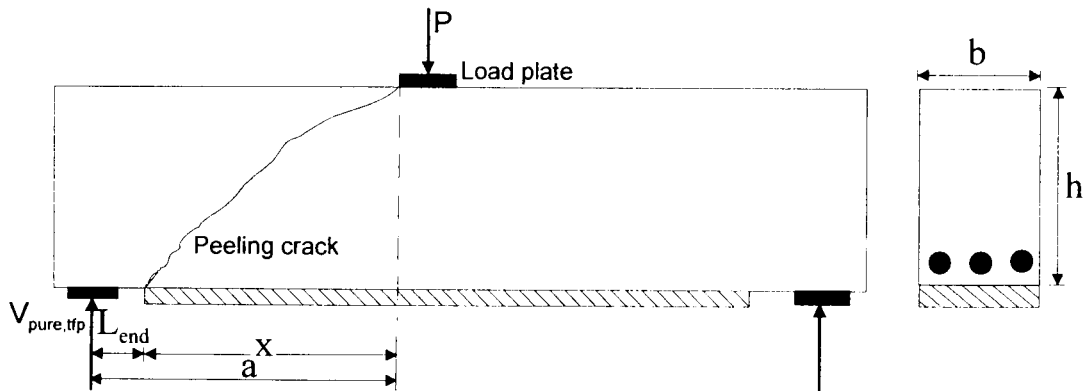
(b) Tension face plated beam ( $x$  known)

Fig.11.13. Location of critical diagonal crack

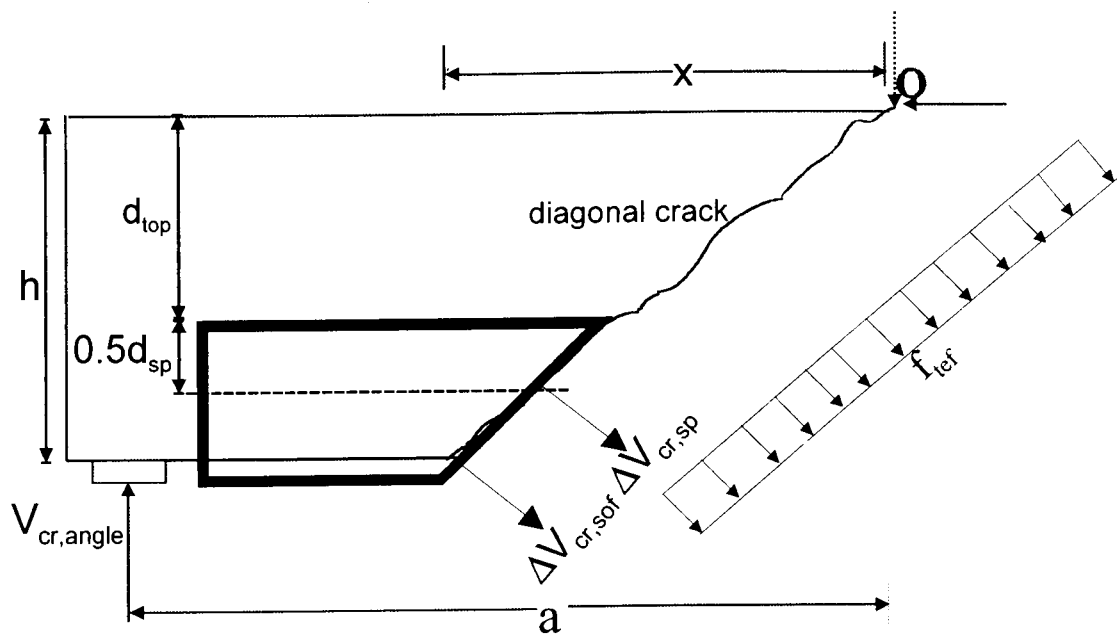
**Fig.11.15. Forces in the diagonally cracked beam**

where  $d_{top}$  is the distance between the beam top to the topmost fibre of the angle,  $d_{sp}$  and  $t_{sp}$  are the depth and thickness of the side plate of an individual angle and  $b_{sof}$  and  $t_{sof}$  are the width and thickness of the soffit plate of an individual angle, as shown in Fig.11.16.

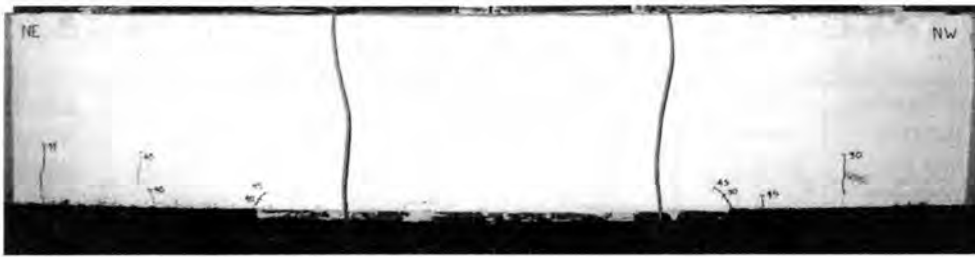
This beam was provided with a 20 mm thick steel plate at its tension face. The initial crack formation for this beam is shown in Fig.12.4. It can be seen that a flexural crack first occurred in the unplated region at an applied moment of 22.5 kNm (that is an applied load  $P=30$  kN) and a small crack also appeared adjacent to the north-west and south west plate ends simultaneously. The minor plate end cracks were transformed into fully fledged debonding cracks at both plate ends as the moment was increased from 30 kNm to 49.5 kNm ( $P= 40$  kN to 66 kN). The complete flexural peeling of the plate is considered to have occurred at 46.4 kNm ( $P = 61.9$  kN) when all the strain readings showed a falling trend. The test was terminated at 51.1 kNm ( $P = 68.1$  kN). Figure 12.5 shows the final crack pattern of this beam.

**Fig.12.4. FP-T20: Initial flexural crack pattern**

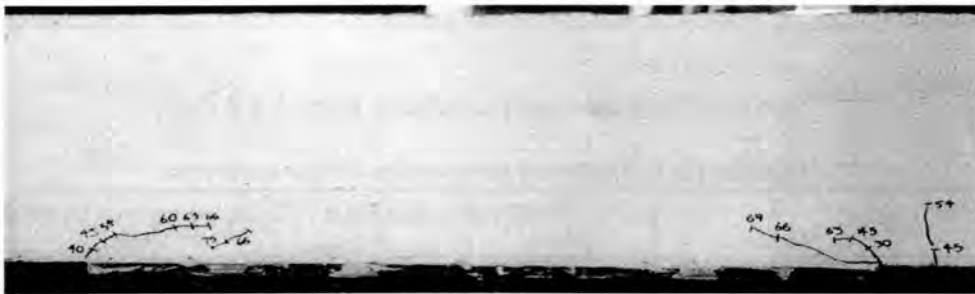
**Fig.12.5. FP-T20: Crack pattern near plate ends at debonding**

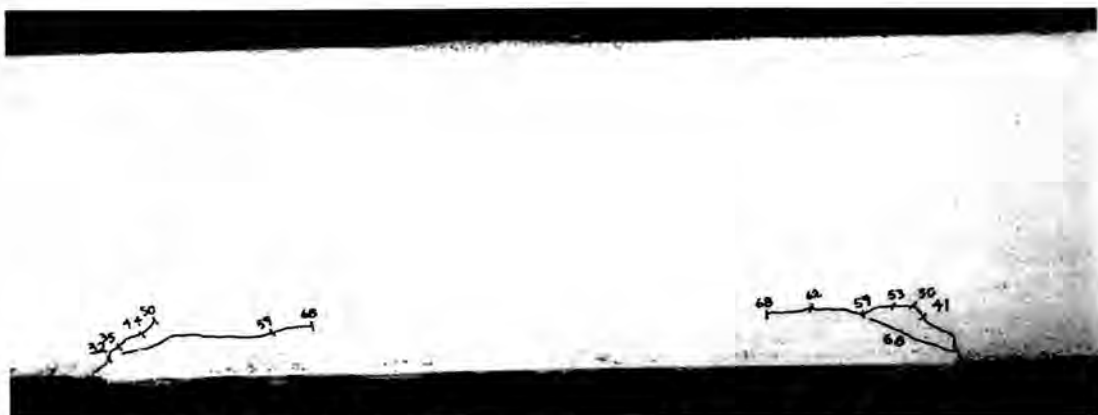
**Fig.12.9. FP-T25: Crack pattern near plate ends at debonding**

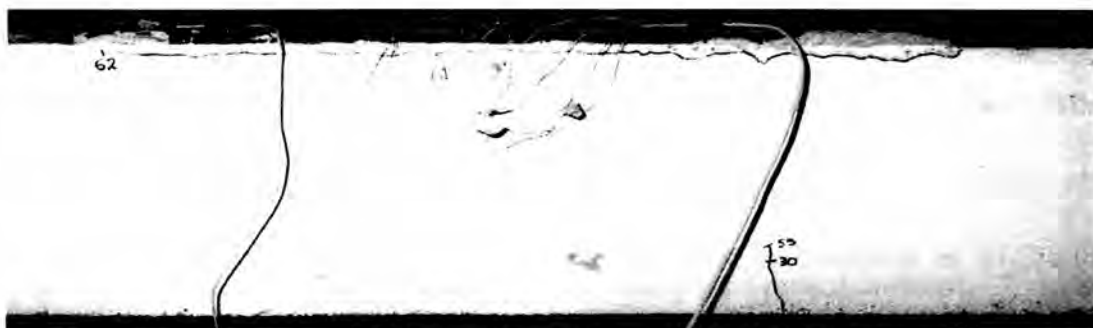
This beam was bonded with a 20 mm thick plate to its compression face. The first flexural cracks occurred in the constant bending moment region at a moment of 22.5 kNm ( $P=30$  kN) and they stabilised at 41.3 kNm ( $P=55$  kN) as can be seen in Fig.12.12. At 45.1 kNm ( $P=60$  kN), a long debonding crack occurred below the centre point of the plate extending towards one end of the plate as shown in Fig.12.12;

**Fig.12.12. Long debonding crack in FP-C20**

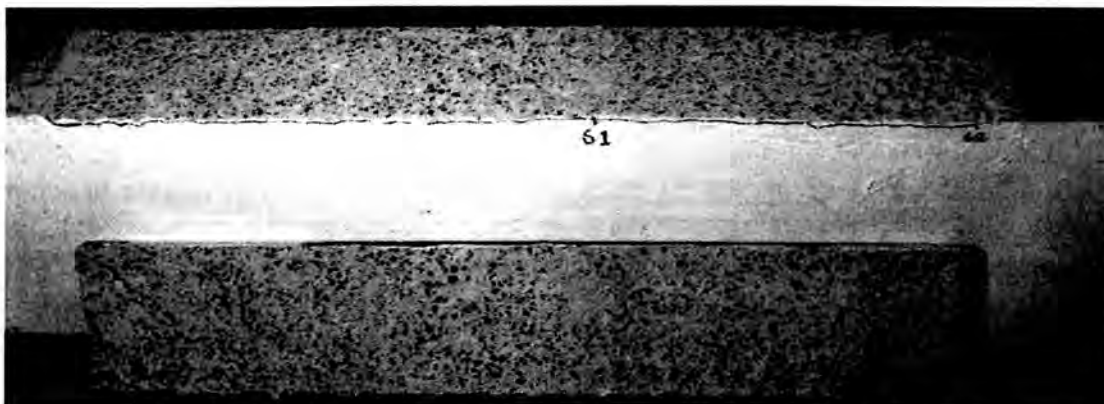
a small increase in applied load corresponding to 47.3 kNm ( $P=63.1$  kN).caused the plate to debond completely as the debonding crack propagated all around the bottom edge of the compression face plate as shown in Fig.12.13. Table-12.6 gives the results obtained from this test.

**Fig.12.13. View after removing plate from concrete-FP-C20**

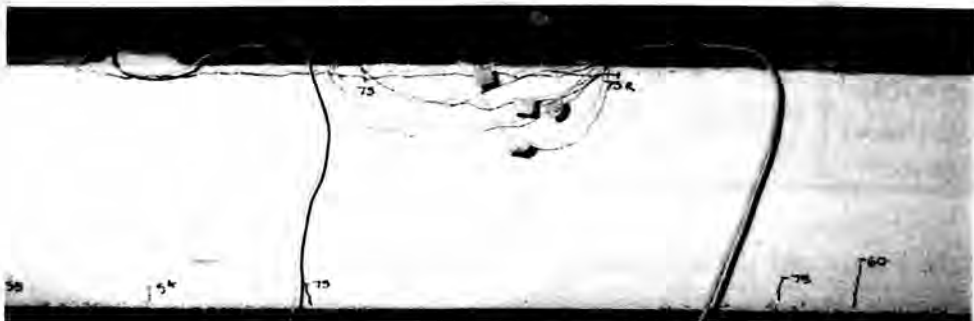
This beam was bonded with a 25 mm thick steel plate to its compression face. A number of flexural cracks appeared and propagated within the constant bending moment region between 22.5 kNm and 56 kNm ( $P = 30$  to 75 kN). At 56.8 kNm ( $P=75.7$  kN), a debonding crack extended from the plate end to the centre as shown in Fig.12.16 and the load dropped to 73 kN. Upon further application of the original moment of 56.8 kNm ( $P=75.7$  kN), the debonding crack propagated to the other plate end and thus complete debonding of the plate occurred as shown in Fig.12.16. Figure 12.17 depicts the scene after the plate was removed from the concrete and it shows that the failure did not occur along the adhesive layer.

**Fig.12.16. Long debonding crack in FP-C25**

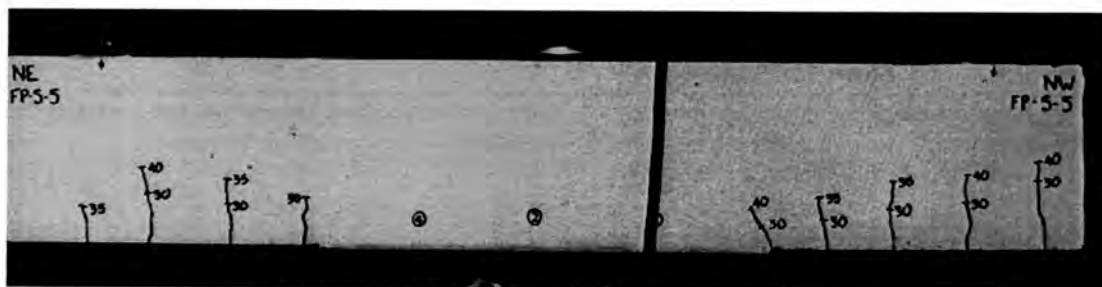
The initial crack formation for this beam is shown in Fig.13.5. It can be seen that a number of flexural cracks first occurred in the unplated region at an applied moment of 12.0 kNm (that is an applied load  $P=30$  kN) and a small crack also appeared adjacent to the northwest plate end simultaneously. Flexural cracks occurred at the remaining plate ends as the moment at the plate end was increased to 18 kNm ( $P=45$  kN). The minor plate end cracks were transformed into fully fledged debonding cracks at both plate ends as the moment was increased from 22.0 kNm to 30.0 kNm ( $P=55$  kN to 75 kN). The complete flexural peeling of the plate is

**Fig.13.5. FP-S-5: Initial flexural crack pattern**

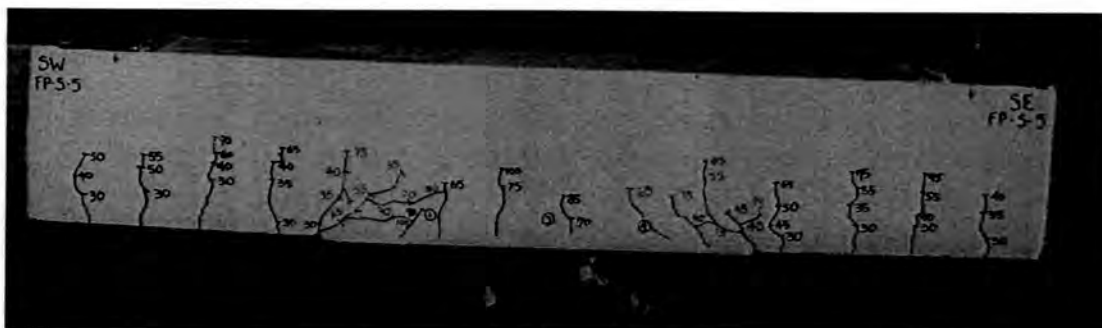
**(b) South side**

**Fig.13.6. FP-S-5: Crack pattern near plate ends at debonding**

considered to have occurred at 26.3 kNm ( $P=61.9$  kN) when all the strain readings showed a falling trend. The test was terminated at 51.1 kNm ( $P=65.6$  kN). Figures 13.6a and 13.6b show the final crack pattern of this beam.

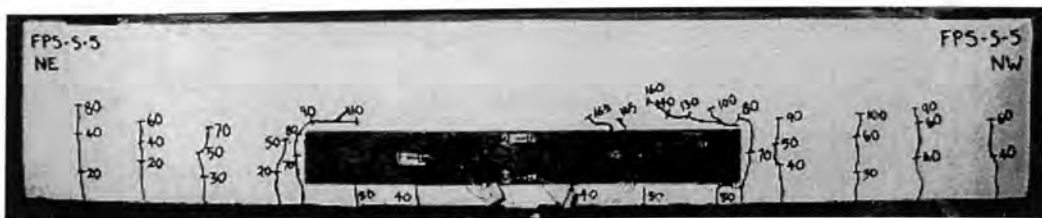
(a) North side

Fig.13.32. FPS-S-5: Crack pattern near plate ends at debonding

Figs.13.32a and 13.32b. Moreover, new cracks also branched out from these horizontal peeling cracks. All these phenomena occurred over wide range of applied moment of 32.0-67.0 kNm ( $P = 80-165$  kNm). The test was terminated at 72.0 kNm ( $P=180$  kN), as no further propagation in peeling cracks was observed. The complete flexural peeling of the plate is considered to have occurred at 48.0 kNm ( $P=120.1$  kN) when the strain magnitudes at the centroid of both the side plates started to fall, as shown in Fig.13.33c.

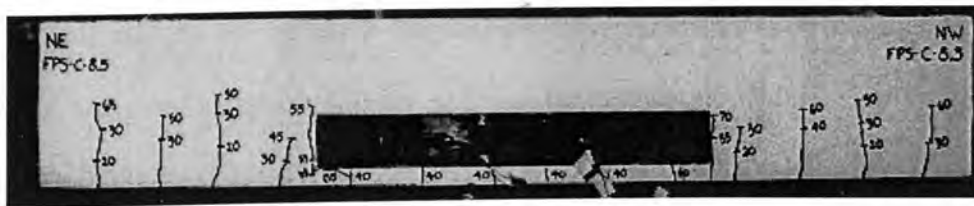
Several flexural cracks first occurred in the unplated region as the applied moment was in the range 8.0 kNm-16.0 kNm (that is an applied load  $P=20-30$  kN) as shown in Fig.13.35. Flexural cracks also appeared below the side plates when the applied moment was varied from 16.0 kNm to 20.0 kNm ( $P=40-50$  kN). The next significant cracks to occur were the ones that formed in the vicinity of the plate ends, when the moment was increased to 22.0 kNm ( $P=55.0$  kN) as shown in Fig.13.35. The plate end cracks first extended to the top corner of the side plates and then propagated

Fig.13.35. FPS-C-8.5: Initial flexural crack pattern

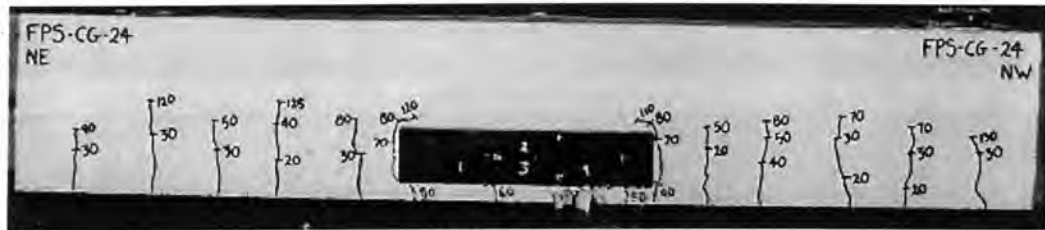
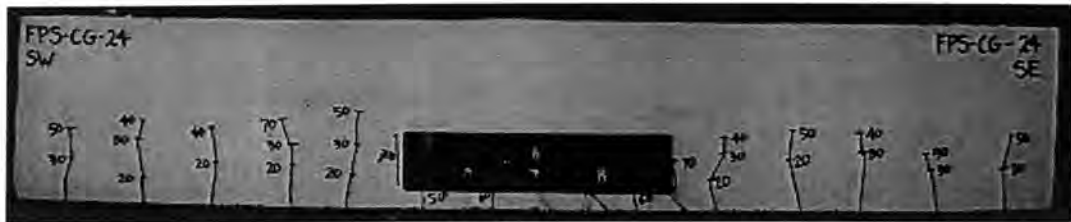
region as the applied moment was in the range 8.0 kNm-16.0 kNm (that is an applied load  $P=20-30$  kN) as shown in Figs.13.39a and 13.39b.

Fig.13.39. FPS-CG-24: Initial flexural crack pattern

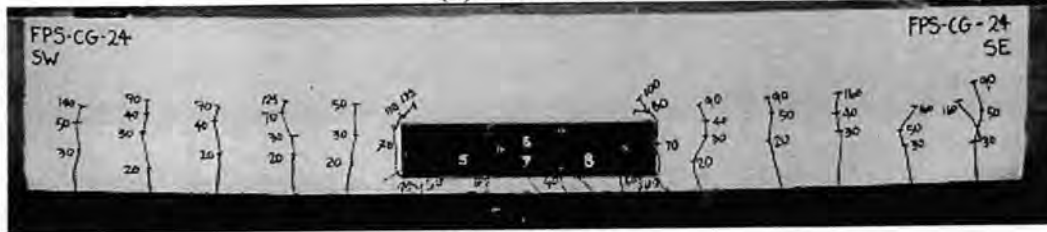
(b) South side

Fig.13.40. FPS-CG-24: Final crack pattern

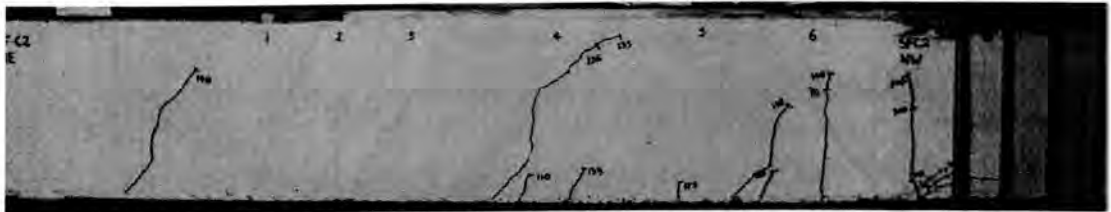
Fig.14.11. SF-C2: Formation of diagonal and flexural shear crack

Two flexural cracks could be observed on either side of the load point when the applied load was in the range of 90-100 kN ( $V=56.5$ - $62.8$  kN). When the applied load was 125 kN ( $V=78.5$  kN), a flexural shear crack formed from the root of an existing minor flexural crack that was at 900 mm from the support, as can be seen from Fig.14.11. As the load was increased to 140 kN ( $V=87.87$  kN), a new diagonal crack appeared in the vicinity of the support. On increasing the applied load to 150 kN ( $V=94.1$  kN), the flexural shear crack propagated along the bottom edge of the plate, as shown in Fig.14.12. This caused the formation of a long horizontal debonding crack that propagated towards the plate end and causing the plate to completely debond as shown in Figs.14.12 and 14.13. The applied load dropped to 110 kN ( $V=69.0$  kN) at which the load test was terminated.

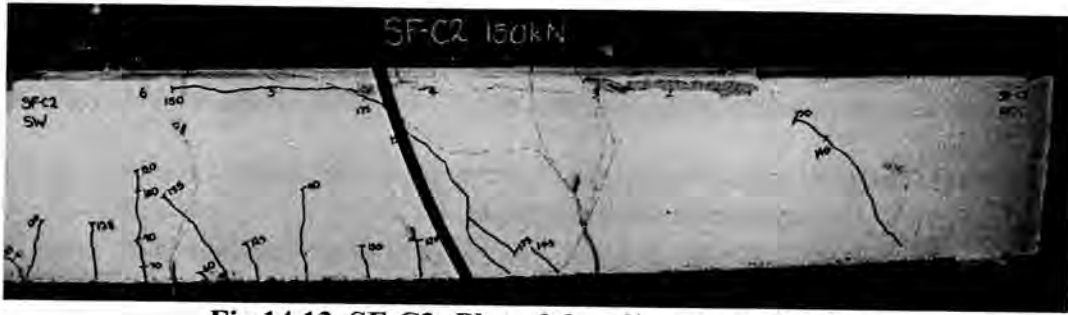
**Fig.14.13. SF-C2: Plate debonding on south side**

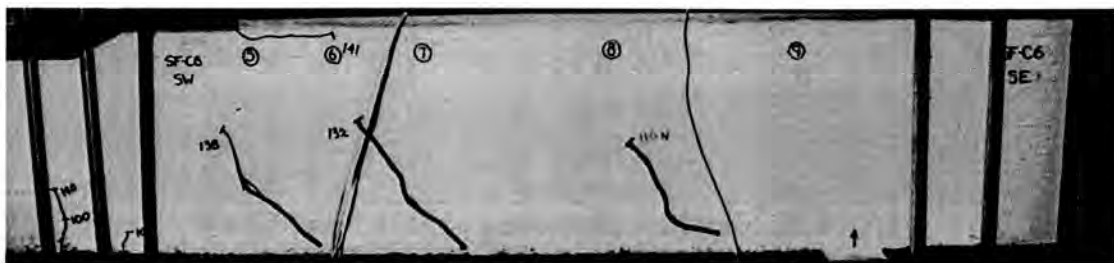
**Fig.14.33. Test SF-C6(a): Crack pattern on south side**

cracks in the region between the plate end and the load point on the north side of the beam when the applied load was in the range 100-138 kN ( $V=47-64.9$  kN). On the south side of the beam, two flexural shear cracks; one at 132 kN ( $V=62.1$  kN) and another at 138 kN ( $V= 64.9$  kN), occurred as can be seen in Fig.14.33.

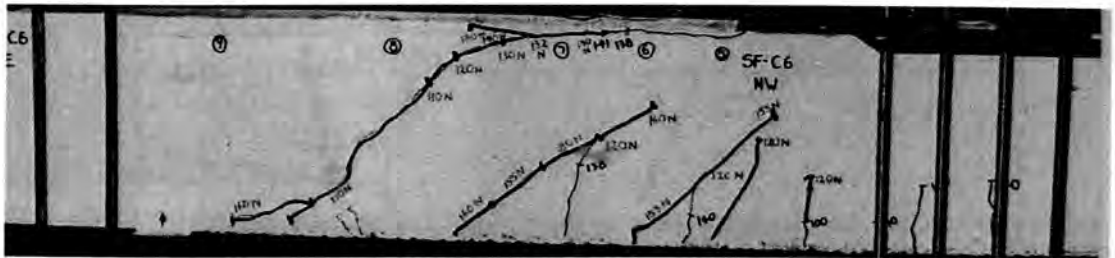
(a) Crack pattern on north side

Fig.14.36. Test SF-C6(b): Crack pattern

Figures 14.36a and 14.36b depict the crack patterns observed on the north and south side of the beam. The crack pattern from test SF-C6(a) is also shown on these figures. The crack pattern from the present test is distinguished by marking the load with suffix 'N' such as 120N and 140N. The first significant change to occur was the formation of a long diagonal shear crack at a distance of 230-250 mm from the support when the applied load was 110 kN ( $V=73.8$  kN). This crack propagated gradually upwards with the applied load and joined with the debonding crack at the

plate end from the previous test at an applied load of 130 kN ( $V=87.2$  kN). At this stage the length of the horizontal debonding crack was 255 mm on the north side and 425 mm on the south side. As the load was increased, new flexural shear cracks formed either adjacent to the existing cracks or from their roots as can be seen in Figs.14.36a and 14.36b.

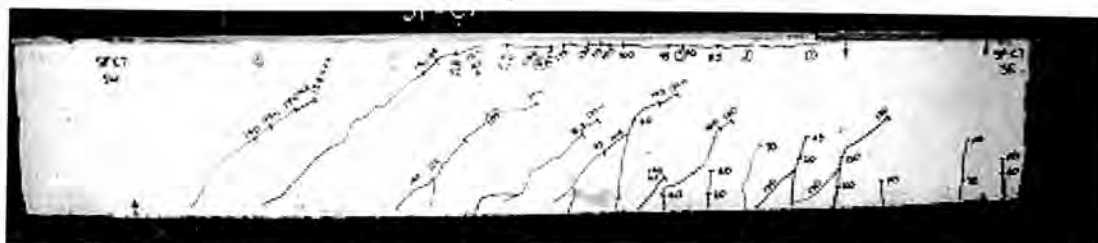
(b) Crack pattern on south side

Fig.14.48. Test SF-C7(c): Crack pattern

Figures 14.48a and 14.48b depict the crack patterns observed on the north and south side of the beam. The existing crack patterns from tests SF-C7(a) and SF-C7(b) are also shown on these figures. The crack pattern from the present test is distinguished by marking the load with suffix 'N2' such as 157N2 and 140N2.

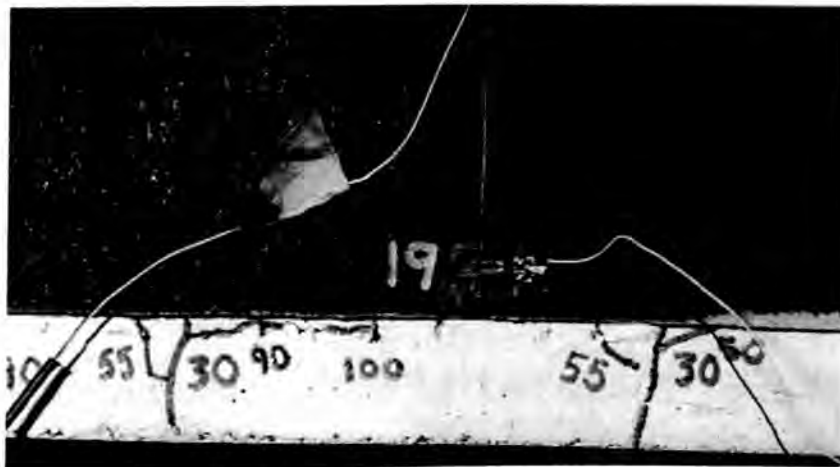
(b) Close view of local debonding crack formation below side plate

Fig.16.3. Test-2B: Crack patterns

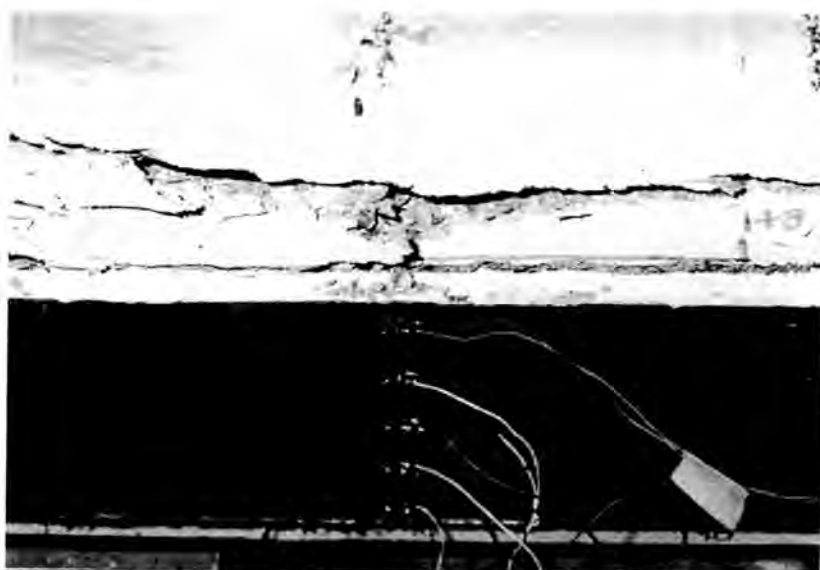
(b) Close view of crushing of concrete and debonding of plate

Fig.16.4. Test-2B: Final crack patterns

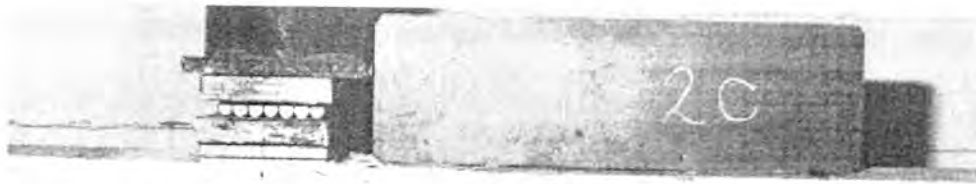
**Fig.16.10. Onset of concrete crushing below load plate**

At an applied load of 153 kN ( $M=174$  kNm), the extreme top fibre concrete beneath the load point started crushing gradually, as shown in Fig.16.10. This process continued till the load was 175 kN ( $M=199$  kNm) at which the compressive concrete failed completely and the load suddenly dropped to 164 kN ( $M=186.6$  kNm). Further application of displacement increased the magnitude of the applied load to 170.2 kN ( $M=193.6$  kNm) but the beam could not sustain the applied load fully and it dropped to 167.8 kN ( $M=190.8$  kNm). The applied load started decreasing rapidly thereafter. During this interval, long debonding cracks occurred along the top level of the plates and the north side plate debonded accompanied by buckling at a reapplied load of 140.3 kN ( $M=159.6$  kNm), as shown in Fig.16.11a. The south side plate also completely debonded in a similar fashion at a reapplied load of 119.4 kN ( $M=135.8$  kNm), at which the test was terminated as can be seen in Fig.16.11b.

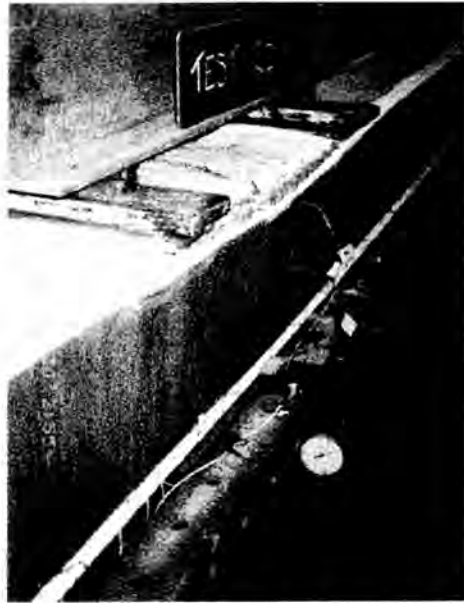
(a) North side plate

Fig.16.18. Test-2D: Debonding of side plates

As the load was increased to 203.4 kN ( $M=200.8$  kNm), the concrete fibres above the side plates in the constant bending moment region started crushing. This led to the formation of long debonding cracks along the top of the plate, as shown in Fig.16.17; the load suddenly dropped to 196.7 kN ( $M=194.2$  kNm). As the concrete started crushing, further application of the load caused the compressive force to be transferred to the side plates. This eventually led to the local buckling of the south side plate when the reapplied load was 167.8 kN ( $M=165.7$  kNm), as can be seen in Fig.16.18b. Finally, both the plates debonded from the concrete when the recorded load was 132.8 kN ( $M=131.1$  kNm) and this is illustrated by the Figs.16.18a and 16.18b.

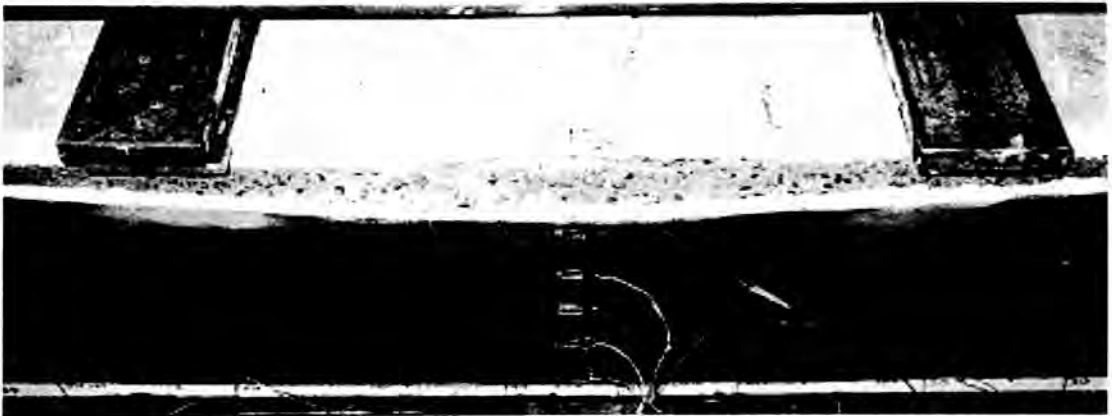
(b) Local buckling and debonding of south side plate

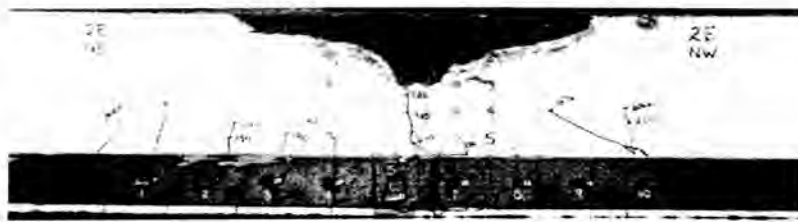
Fig.17.3. Repairing of Beam-2E

Three tests were conducted on the side plated beam. Firstly, it was tested by four-point loading and this test was designated as test-2E as shown in Fig.17.2. After the completion of test-2E, the beam was repaired as shown in Fig.17.3 and new plates were bonded to the sides. Then, two identical but individual tests (Tests-2ES1 and 2ES2-(Refer Fig.17.4) were conducted on the two shear spans of the Beam-2E which was bonded with full length side plates (100mm deep and 6 mm thick) that were folded around the corners of the beam. The load was applied 1200 mm away from the nearest support; the failure in the longer shear span was prevented by clamping it as shown in Fig.17.5.

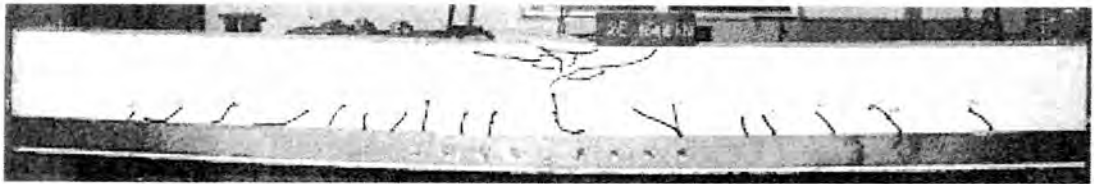
Fig.17.14(b). Overall crack pattern at closure of test

Crack growth could not be observed until the maximum bending moment  $M$  was 95.0 kNm ( $P=100$  kN) due to the presence of side plates; at this moment a flexural crack was seen above the side plate in the constant moment region as shown in Fig.17.14a. This figure also shows the test rig, demec discs and strain gauges bonded to the side plates. As the applied load was increased, new flexural cracks appeared in the constant moment region and they extended vertically; flexural shear cracks and diagonal cracks formed in the shear spans as shown in Fig.17.14b.

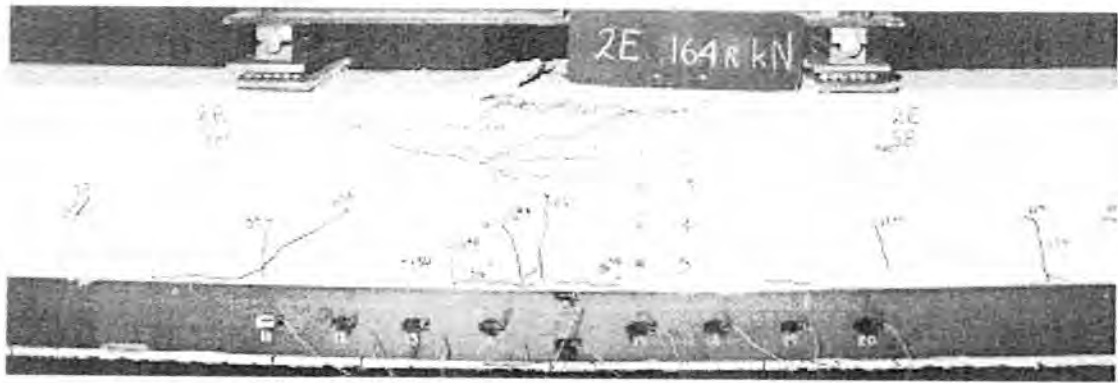
**Fig.17.14(d). Concrete crushing in south side**

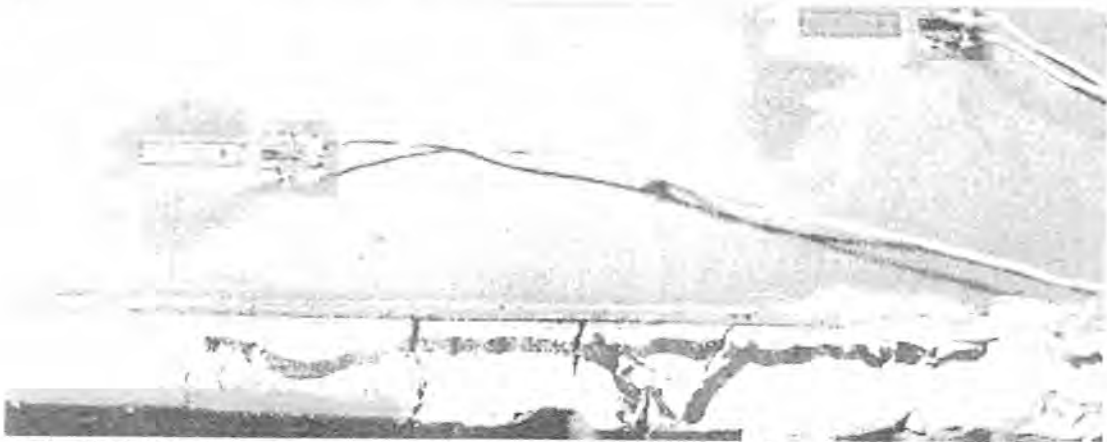
**Fig.17.14(e). Close view of debonding crack beneath plate in constant moment region**

**Fig.17.14. Crack pattern and failure mode in Test-2E**

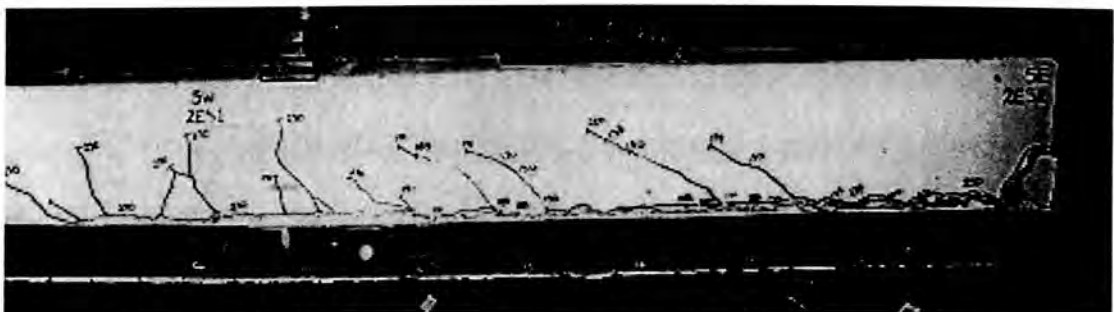
**Fig.17.18 (d).Complete debonding of south side plate**  
**Fig.17.18. Test-2ES1: Crack patterns**

As the load was increased further in 3 kN increments, two more similar debonding cracks formed from the roots of two other inclined cracks. The three horizontal cracks propagated steadily backwards and they stabilised at an applied load of 185 to 188 kN ( $V=137.8$  to 140 kN), as shown in Fig.17.18b. Debonding cracks also formed from the two inclined cracks close to the load point when the applied load was in the range of 191-194 kN ( $V=142.3$ -144.5 kN). Moreover, the debonding crack close to the support extended further when the applied load was 221 kN ( $V=164.6$  kN), as can be seen from Fig.17.18c.
