Lisa Moon, David Biggs, Jason Ingham, and Michael Griffith
Transect survey as a post-disaster global rapid damage assessment tool
Earthquake Spectra, 2015; 31(4):2443-2457

Transect Survey as a Post-Disaster Global Rapid Damage Assessment Tool

Lisa Moon^{a)}, David Biggs,^{b)} M.EERI, Jason Ingham,^{c)} M.EERI and Michael Griffith,^{a)} M.EERI

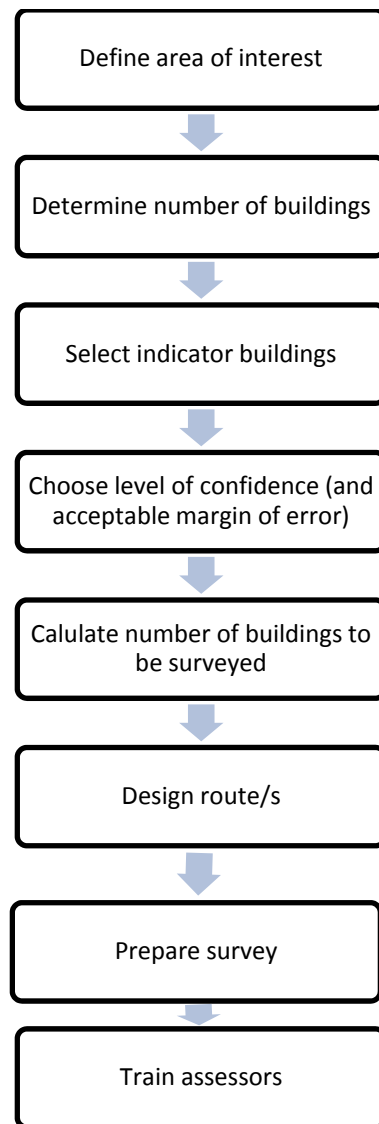
Figure 1. Flow chart of transect design

As part of emergency management planning, a transect survey can be pre-planned and prepared for use in estimating the overall level of building damage immediately following a large damaging earthquake or other disaster. A pre-selected route could be designed such that rapid damage assessments of all buildings directly along the route (on both sides of the street) could be used as a sample to estimate the overall level of building damage to a predefined level of confidence. For a geographical region having varying building types and varying soil conditions across the region, the procedure could be deployed multiple times through smaller sub-regions having approximately homogenous building stock and ground conditions in order to provide accurate regional surveying. A flowchart of the steps required to design such a survey is shown in **Figure 1** and these steps are expanded beyond.

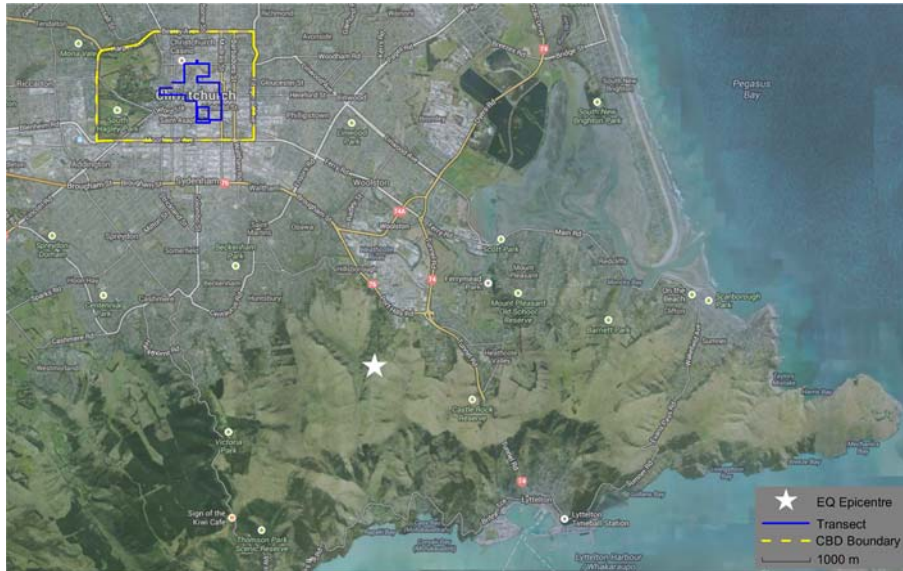
Figure 2. Route of the 24 February 2011 transect

The transect route was chosen to encompass a large proportion of URM buildings with which the authors were familiar from their previous reconnaissance work following the September 2010 earthquake. Fortuitously, Moon had followed a similar route two days prior to the earthquake and had a photographic record from which the new damage could be identified. Although the route was chosen to include as many URM buildings as possible, all types of buildings encountered along the transect were assessed. The route was also designed to include one of the two multi-storey concrete buildings that fully collapsed in the 22 February 2011 earthquake. Therefore, although the building types recorded during this transect did not exactly reflect the overall distribution of building types within the city, the transect route did contain a sample of all city building types. Because of the significant

(a) View of Christchurch CBD with respect to 22 Feb 2011 epicentre

(b) Location of buildings shown in Figure 4

Figure 4 shows the damage to all the buildings along a short section of the transect route. The locations of buildings 1 – 8 (**Figure 4 (a-h)**) are shown in **Figure 2 (b)**. As can be seen, the range of damage levels varied greatly. Building 1 showed no damage to the timber structure and partial collapse of an external extension to a URM firewall, and so was assigned ‘light’ status. Buildings 2 and 6 also showed no visible damage and were also classified ‘light’. Buildings 3 and 7 showed some external cracking, but appeared to not be in imminent danger of collapse, so were classified ‘medium’. Building 4 exhibited severe cracking and was classified ‘heavy’. Buildings 5 and 8 both suffered extensive damage including loss of external walls and were also classified ‘heavy’. This range in damage levels in small areas was typical of that observed in the Christchurch CBD during the transect.

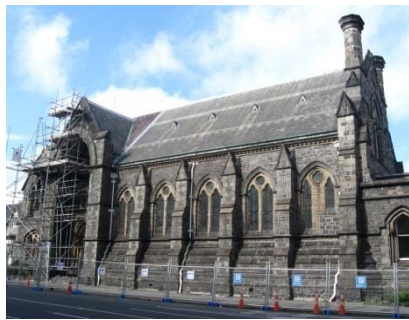
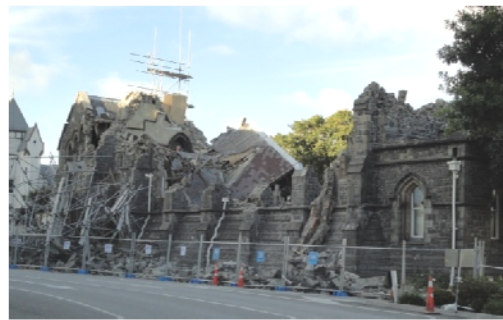
Figure 3. Provincial Chambers building in the Christchurch CBD before and after 22 February 2011

Figure 3 shows photographs of the Provincial Chambers building in Christchurch shortly before and after the 22 February 2011 earthquake, which illustrates the extent to which the February earthquake exacerbated the prior earthquake damage to URM buildings. It is interesting to note that many of the buildings in Christchurch were relatively undamaged prior to the 22 February 2011 earthquake and that the significantly stronger ground shaking induced extensive further damage in both stone and clay brick masonry construction (Moon et al. 2014).

a) 20 February 2011

b) 24 February 2011

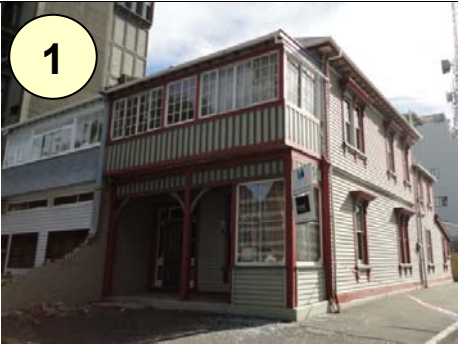
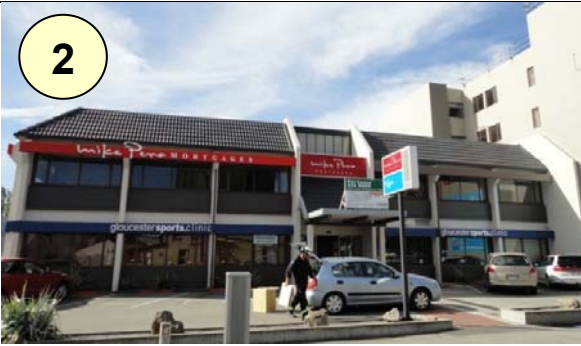
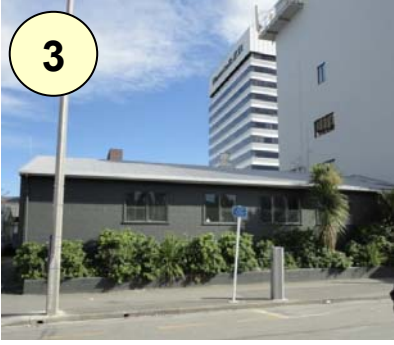
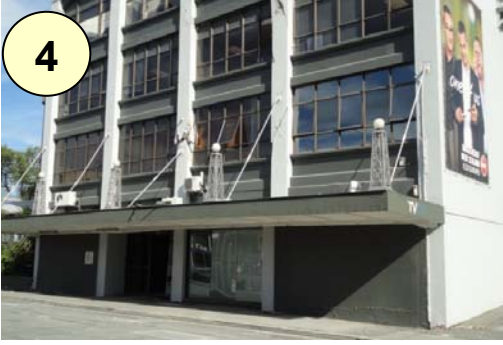
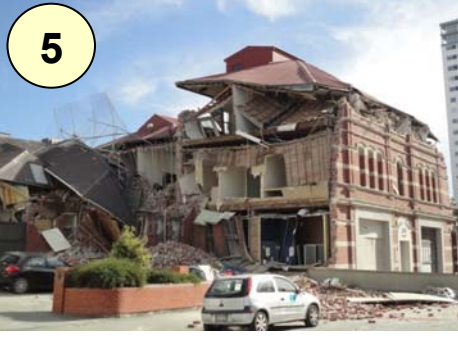
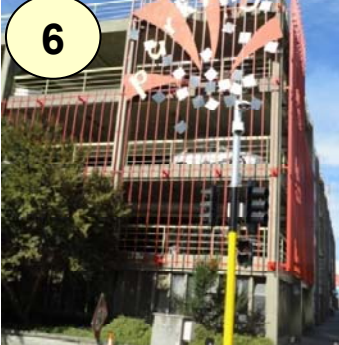
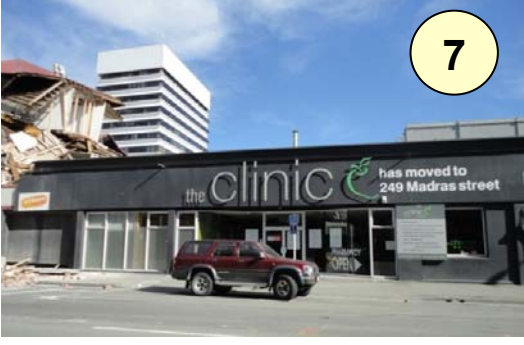
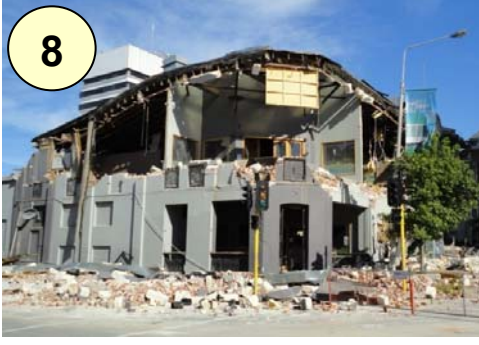
Figure 4. Damage examples along transect

<p>a) Timber – Classification: Light</p>	<p>b) RC with masonry infill – Classification: Light</p>

<p>c) RCM – Classification: Medium</p>	<p>d) RC – Classification: Heavy</p>

<p>e) URM – Classification: Heavy</p>	<p>f) RC – Classification: Light</p>

<p>g) URM – Classification: Medium</p>	<p>h) URM – Classification: Heavy</p>

The data gathered through the transect was also useful to local authorities, including emergency management officials. In addition to the immediate reports of newly identified critically damaged buildings, the transect data provided examples of typical damage observed in different building types. On Friday 25 February, emergency management decided that some ‘indicator’ buildings were to be selected and requested the authors to identify a suite of candidate buildings based upon their transect observations. An example building typical of each construction type was chosen. Subsequently, each ‘indicator’ building was monitored and reinspected after each major aftershock. In the event that an ‘indicator’ building displayed significant additional damage during an aftershock, or showed signs of movement, all buildings of that construction type were then reinspected. Results from the transect allowed those in charge to be more confident that their selection of indicator buildings were representative of particular construction types. Building 4 in **Figure 4(d)** was among those selected as an ‘indicator’ building.

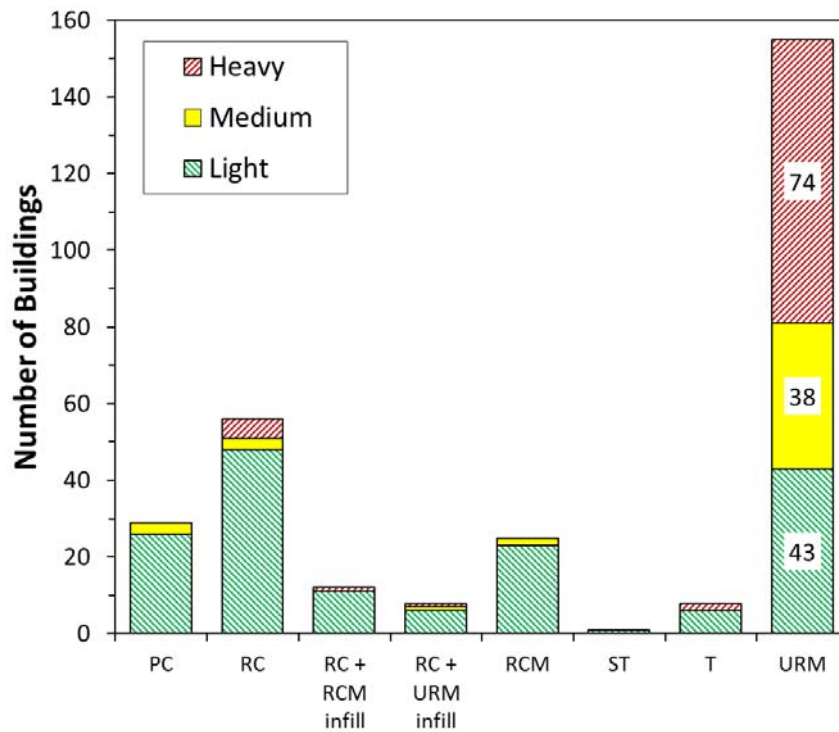
Figure 5. Distribution of damage states for each building type from transect survey

The results of the Christchurch transect observations are shown in **Figure 5**. The graph shows the number of surveyed buildings for each building type, and the breakdown of each building type into the different damage classification colours.

The data presented in **Figure 5** clearly shows that the majority of the buildings were constructed of URM and that they performed the worst during the earthquake. Almost half of all URM buildings were classified as red, compared to less than 10% for all other building types. This extent of damage is to be expected as URM buildings are known to behave poorly when subjected to large lateral loads, and the URM buildings tended to be older and therefore have a lower seismic capacity than newer reinforced concrete or steel buildings.

From the transect data, it was estimated that approximately one-third of all buildings in the CBD would need to be demolished. This estimate was based on the assumption that all of the red tagged buildings and 50% of all the yellow tagged buildings would be uneconomical to repair or would need to be demolished urgently for safety reasons, and that the transect was a good representation of the distribution of and damage to all building types throughout the CBD.

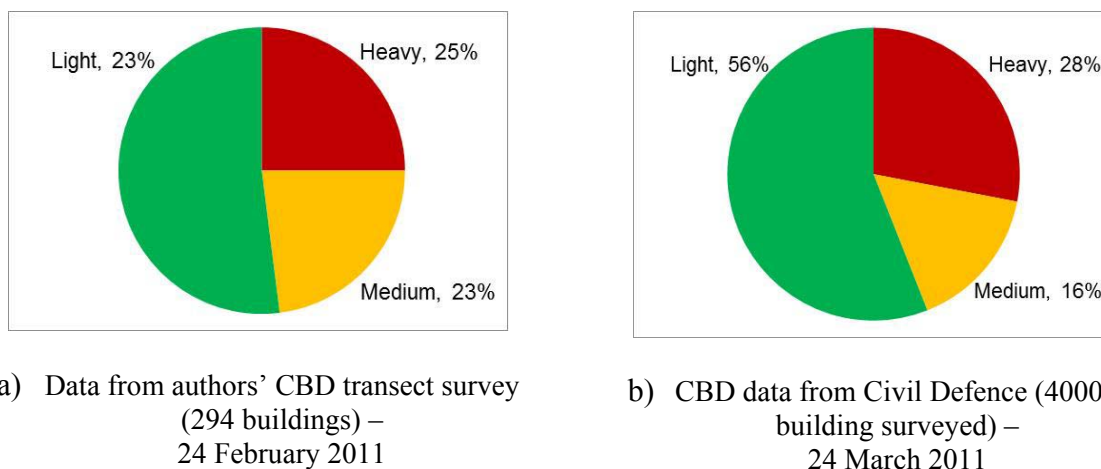
Figure 6. Building damage data for Christchurch CBD, February and March 2011

At the time when the transect was performed, the focus by authorities was on search and rescue. Engineering assessments in the CBD were limited to an ‘as-needed for emergency assessment’ basis and most other engineering resources were assigned to assessing suburban residences. Rapid building assessments in the CBD had not begun, and therefore these results were the first overall study of the damage levels of buildings within the CBD. **Figure 6** shows the overall distribution of damage classifications assigned during the transect (**Figure 6(a)**) and those assigned by the Civil Defence volunteers in the following month (**Figure 6(b)**). The Civil Defence data, published by the Christchurch City Council (2011), covers over 4,000 buildings within the CBD, and shows an overall damage distribution that is strikingly similar to that obtained from the transect which only surveyed 294 buildings, despite there being almost daily aftershocks in the weeks between the transect and the overall study.

Accurate data on the true distribution of building types in the Christchurch CBD is difficult to obtain. While the Civil Defence published data on building damage for over 4,000 buildings (**Figure 6**), the construction types of these building was not revealed. However, building types for 2,711 buildings can be inferred from Christchurch City data reported by Ingham & Griffith (2011b; 2011c) for URM buildings and by Kam et al. (2011) for all other building types. While this building count likely represents about only 60% of buildings in the CBD, it is the best data currently available, and hence is the data used in this analysis.
